## BIGHORN RIVER SIDE CHANNEL RESTORATION POTENTIAL

THE RESEARCH INITIATIVE

**Karin Boyd**

February 2021

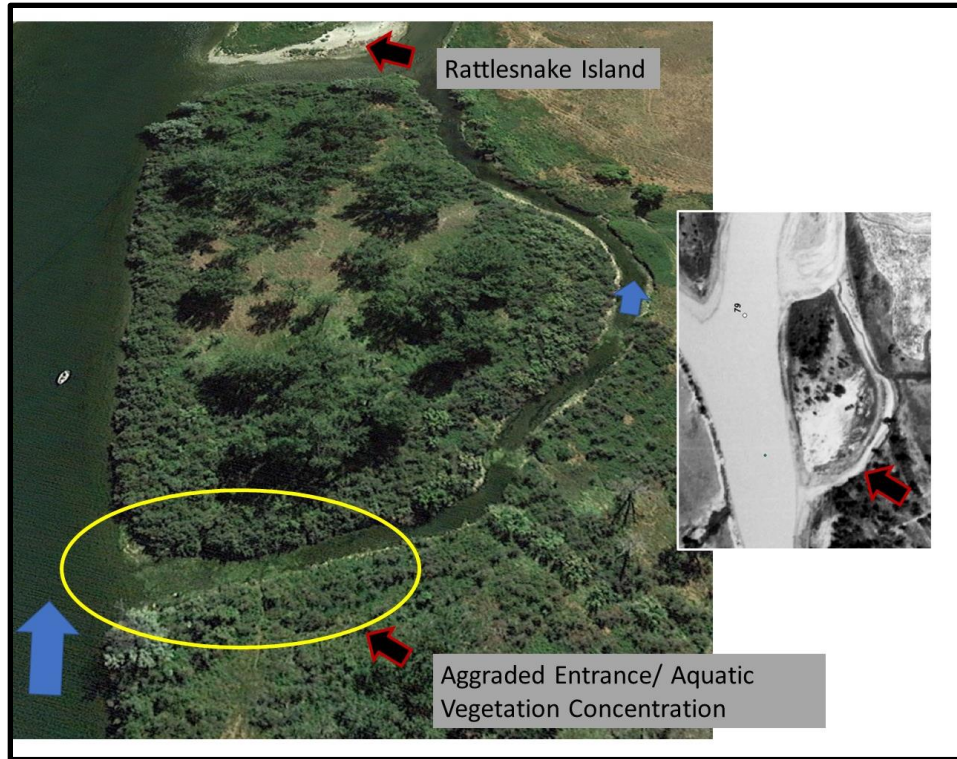
Figure 12. Google Earth Image (2014) showing impaired connectivity at head of channel just upstream of Rattlesnake Island; inset shows channel in 1954.

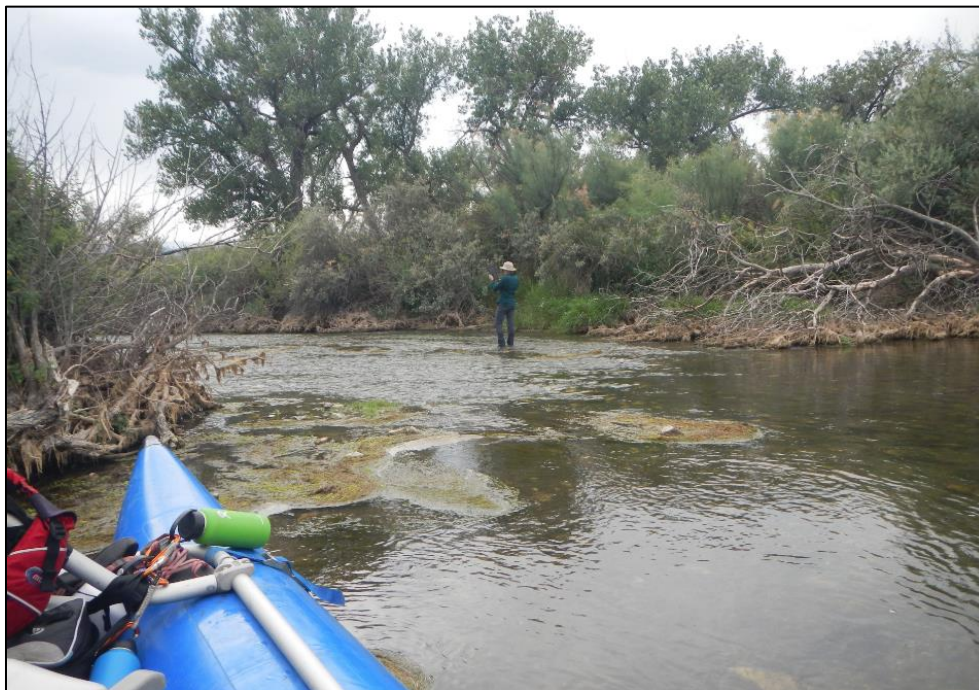
Figure 13. Shallow flow entering Rattlesnake Island channel at 3,200 cfs in September 2019.

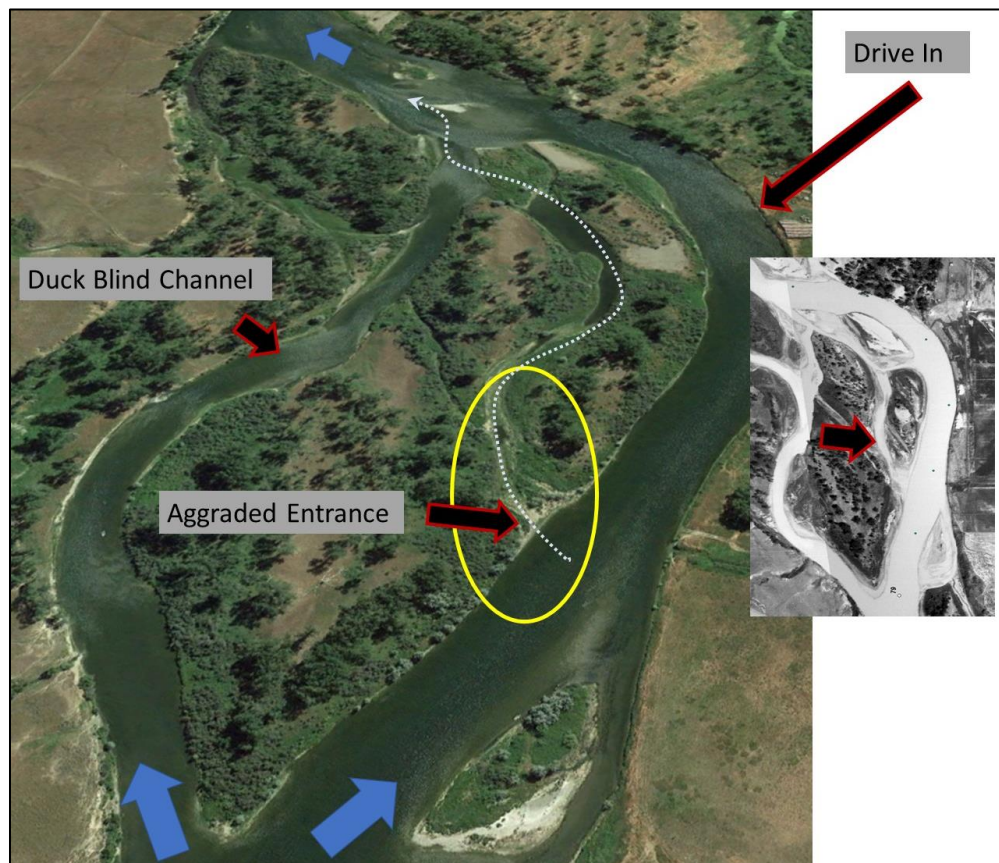
**Figure 16. Google Earth Image (2014) lost connectivity at head of channel just across from Drive In; inset shows channel in 1954.**

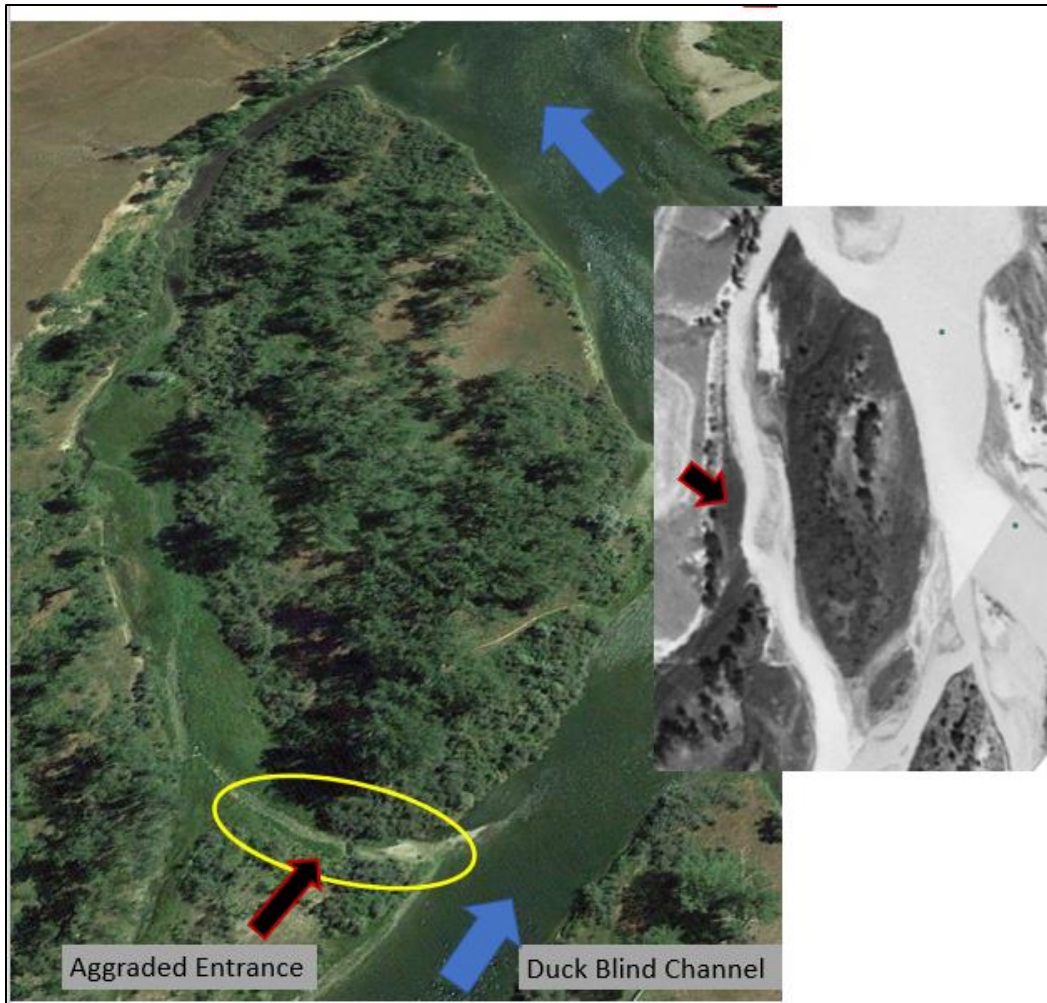
This channel is on the left floodplain and comes off of the Duck Blind Channel at RM 78.5 (Figure 20). According to the USGS, this channel activates at about 8,000 cfs (listed as “complex 8- far left channel in Table 1). This lack of activation is due to relatively high ground that extends about 200 feet down from the channel entrance (Figure 21). The lower end of the channel is a large backwater (Figure 22).

**Figure 20. Google Earth Image (2014) lost connectivity at head of channel at RM 78.5; inset shows channel in 1954.**

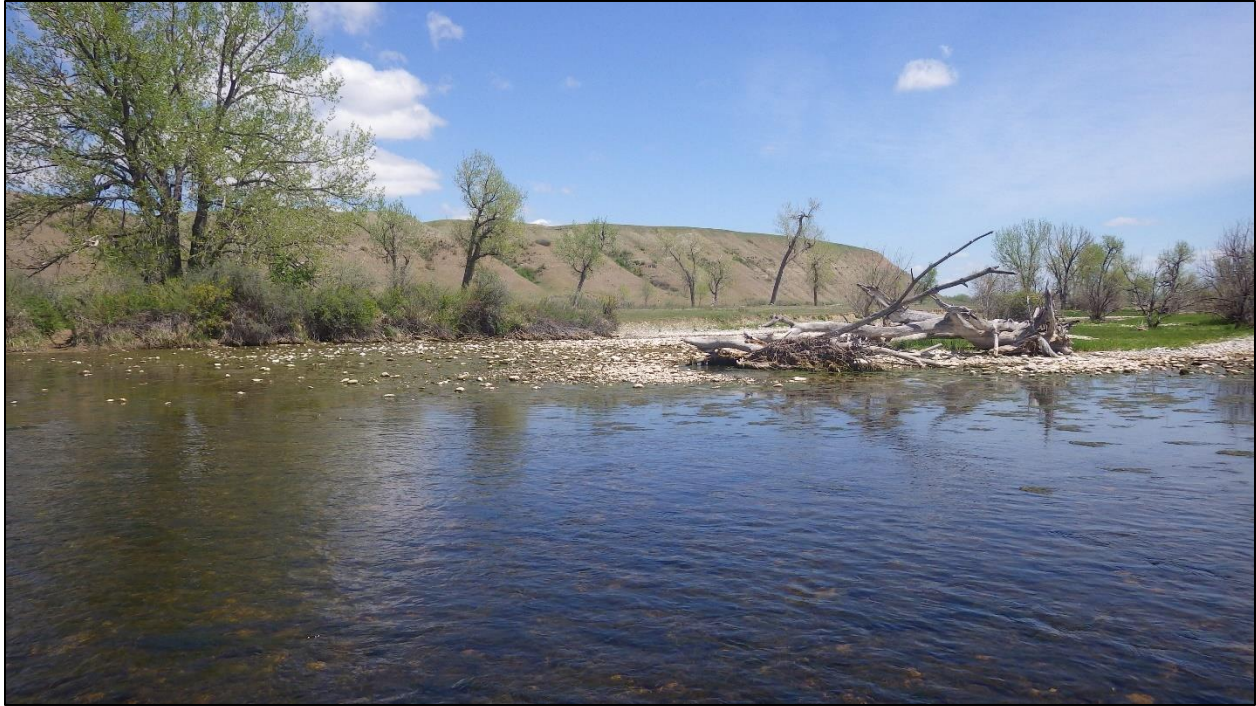
**Figure 24. Entrance to Picture Channel at 2,500 cfs showing minimal connectivity and debris jam at head of flow split on May 19, 2020 (Steve Hilbers photo).**

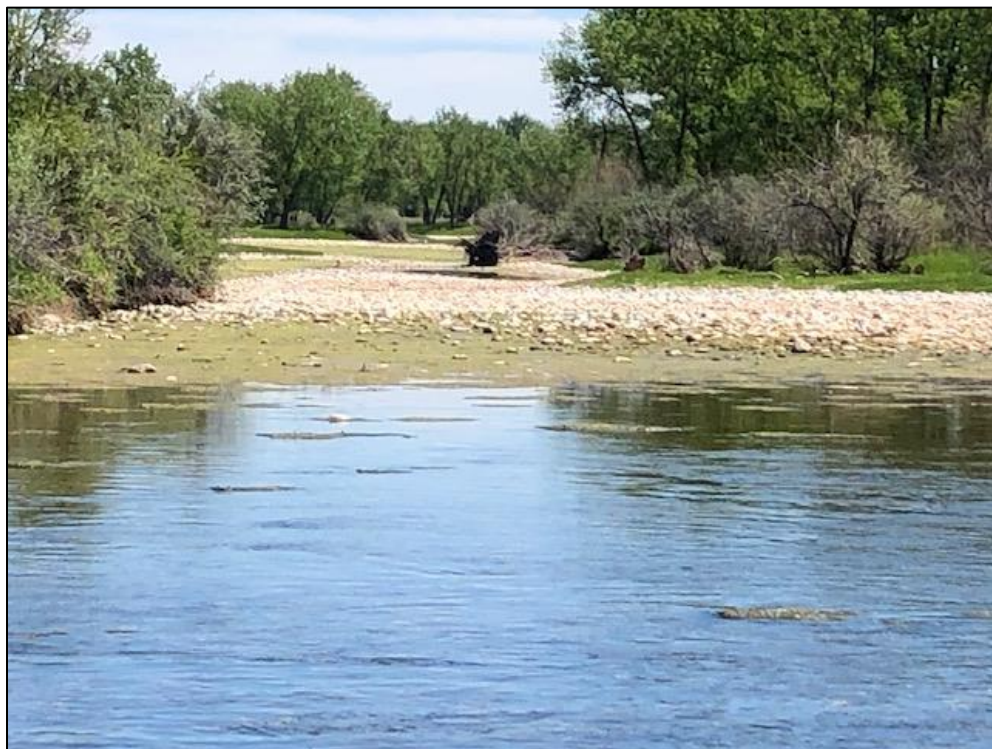
**Figure 25. Entrance to Picture Channel at 2,000 cfs showing dry channel on May 29, 2020 (Jim Chalmers photo).**

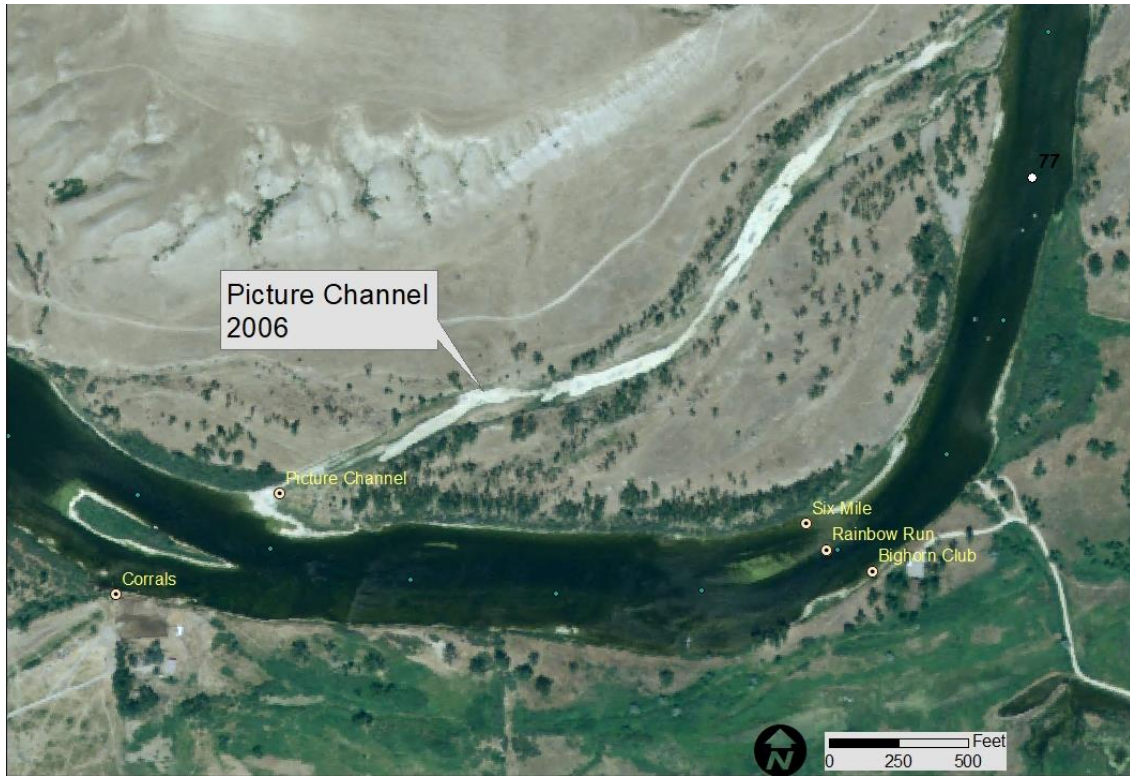
Figure 26. Picture channel completely dry in 2006 imagery (~1,475 cfs).

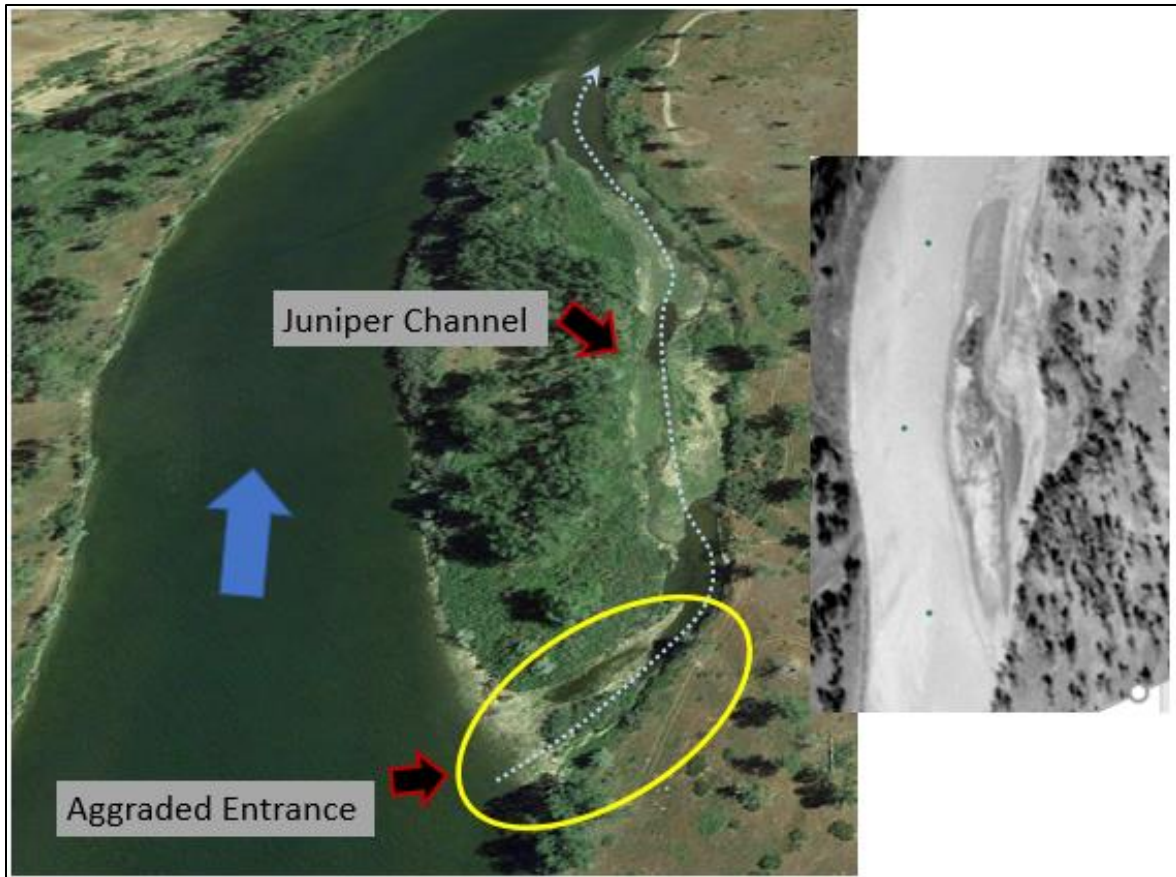
At RM 76.4, the Juniper Channel existed in the 1950s as a secondary channel behind a mid-channel bar. This bar has progressively established as a vegetated island, but the secondary channel has persisted since the dam was built. (Figure 29). The channel was flowing during our field work, when the river discharge was about 3,200 cfs (Figure 30), and in May of 2020 it was dry at 2,500 cfs (Figure 31). Figure 32 shows the entrance at 2,000 cfs. Based on stage comparisons, the estimated activation flow is about 2,900 cfs. If the entrance were dropped about 0.4 feet, the estimated activation could be dropped to about 2,300 cfs, which would wet the channel an additional 50 days per year. The material at the head of the channel is quite coarse, and it appears unlikely that it will naturally scour at high water, so mechanical excavation is likely necessary to maintain connectivity and prevent additional decay through vegetation encroachment onto the cobbles. The shallow water in the foreground of Figure 32 suggests that deep excavation through the head of Juniper Channel may be difficult.

Figure 29. Google Earth Image (2014) lost connectivity at head of channel at RM 76.5; inset shows channel in 1954.

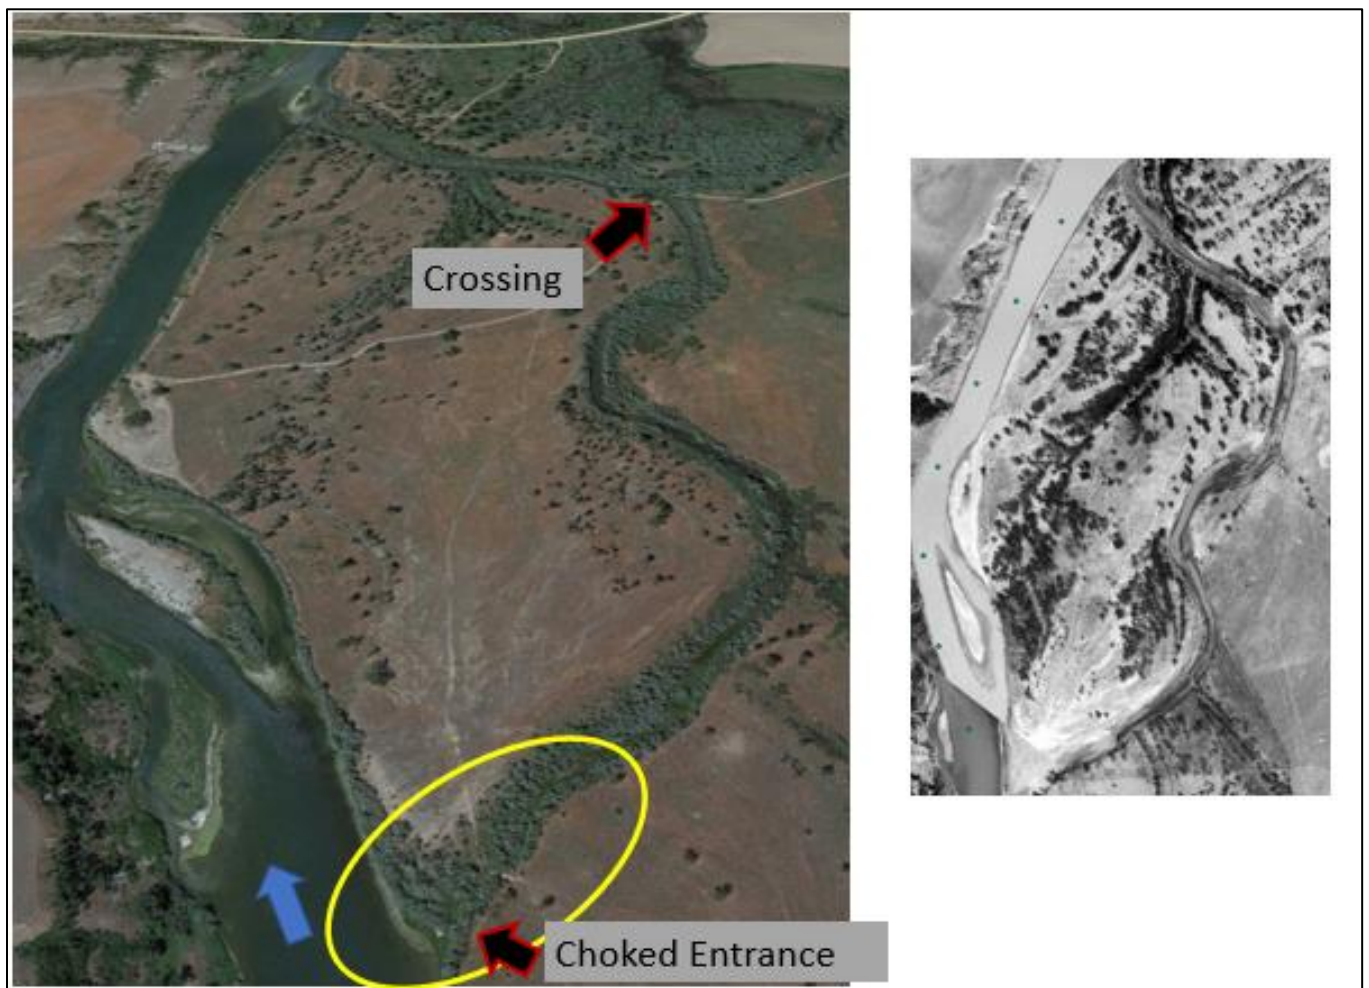
This is a long side channel located on the right floodplain between Turtle Rock and the St Xavier bridge (Figure 33). Based on the LiDAR it appears that the channel has good topographic connectivity, however the entrance is densely choked with Russian olive. There is a primary road crossing about  $\frac{3}{4}$  of the way down the channel that looks to have been improved in recent years through the addition of a culvert. Opportunities for this channel would be somewhat different than the others, in that Russian olive removal and culvert enlargement could potentially increase side channel function. That said, a more detailed evaluation is necessary; imagery shows the channel flowing during the high water of 2011 (~12,000 cfs) but it is difficult to see much activity in any other imagery.

Figure 33. Google Earth Image (2013) showing dense vegetation at head of channel at RM 68.8; inset shows channel in 1954.

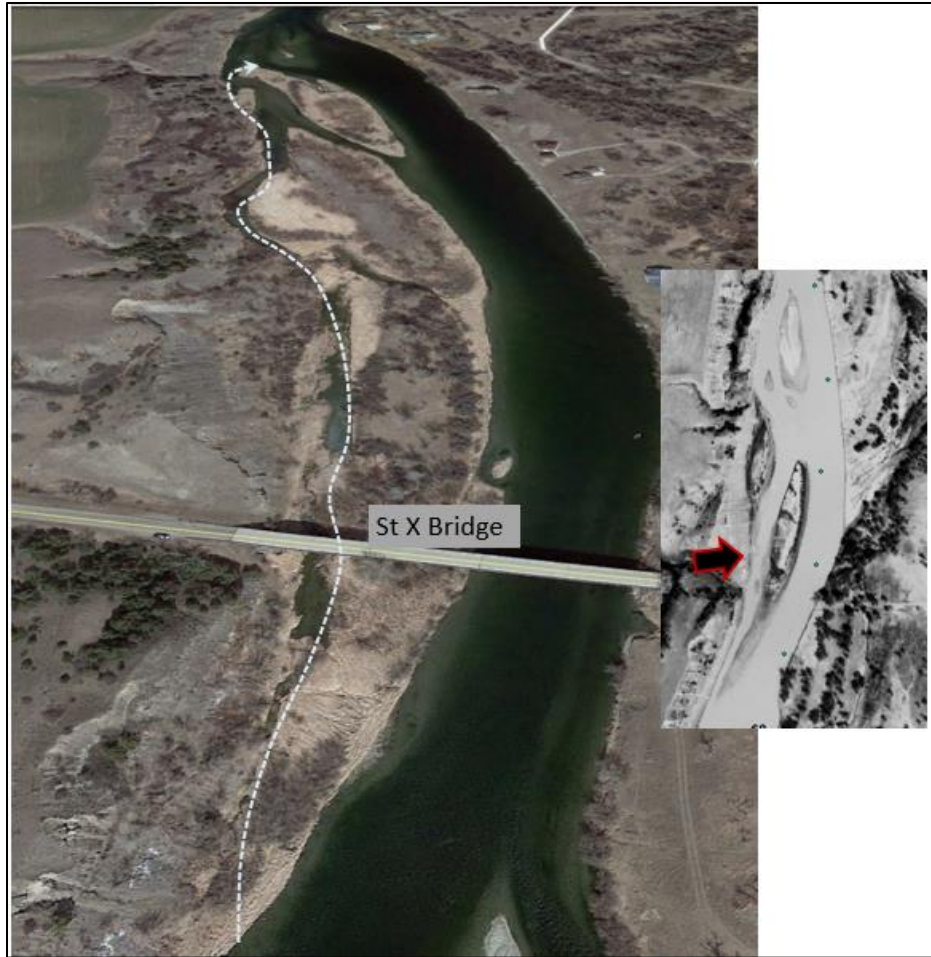
This channel is similar to the Juniper Channel, in that it was within the bankfull boundaries of the main river channel in the 1950s. It flows beneath the St Xavier bridge on the left floodplain (Figure 35). Currently, the channel entrance has several high points that reach up to about 2 feet above the river stage at 6,400 cfs. The profile of the channel shows that excavation could likely extend to about 1.0 feet below the 6,400 cfs line, which would make the channel accessible at about 4,200 cfs. The project imagery shows the channel flowing only in the high water of 2011.

Figure 35. Google Earth Image (2016) disconnected side channel at RM 67.9; inset shows channel in 1954.

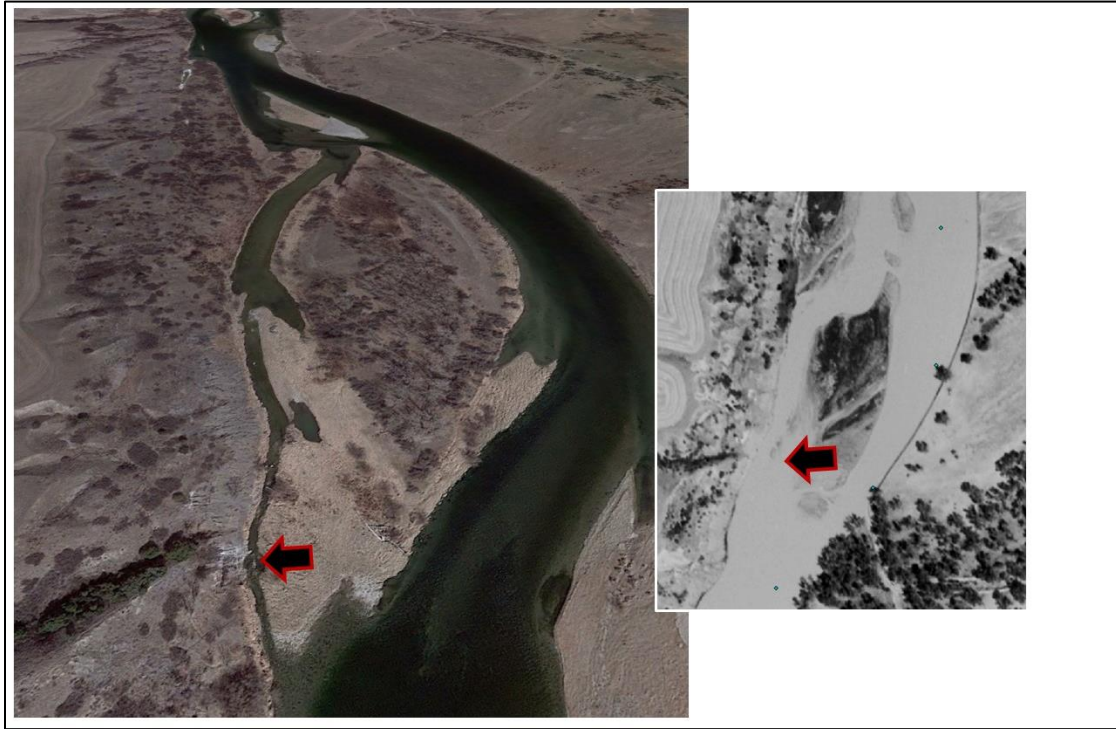
This channel is about 1,500 feet long and it appears that the entrance is progressively decaying, making a project potentially worthwhile (Figure 37). The LiDAR profile shows a distinct blockage on the upstream end of the channel; re-opening that channel would require an estimated 167 cy of excavation (Figure 38).

**Figure 37. Google Earth Image (2016) showing decaying side channel entrance at RM 64.4; inset shows channel in 1954.**

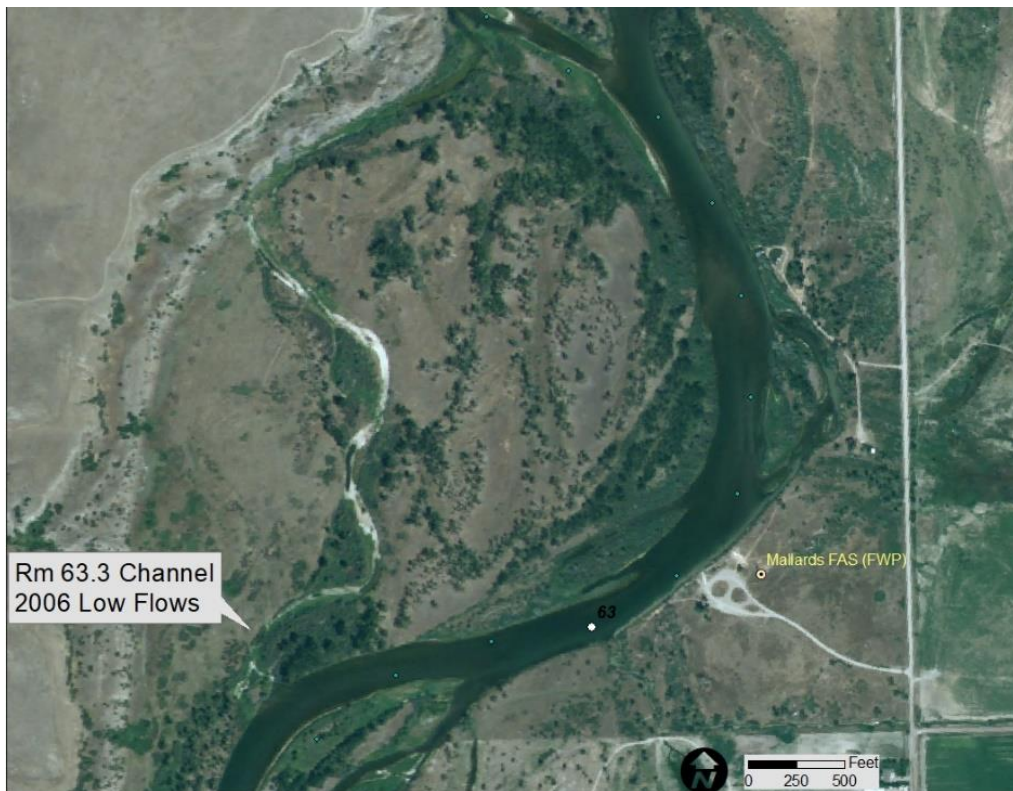
**Figure 39. Channel at RM 63.3 showing dry conditions at low flows in 2006; channel was also not flowing in Google Earth Imagery from summer 2013.**

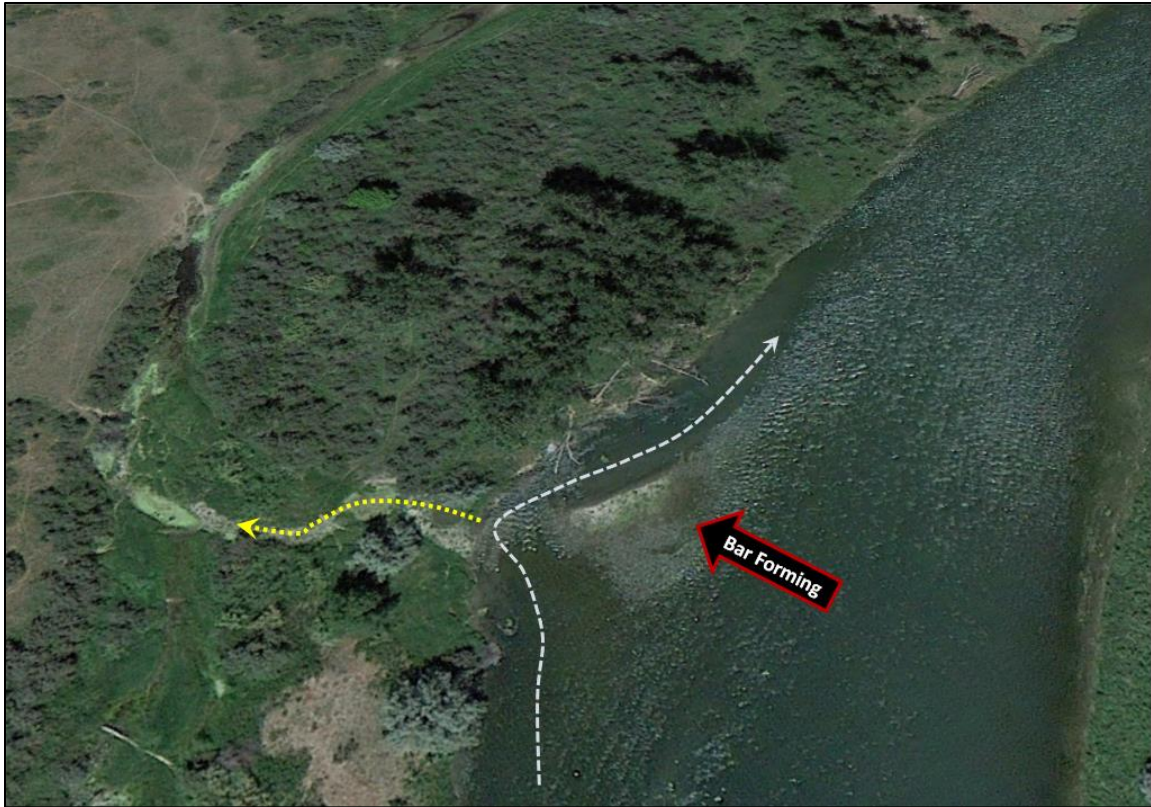
**Figure 40.** Entrance to channel at RM 63.3 showing bar formation at entrance—channel was not flowing when this image was taken in July 2013.

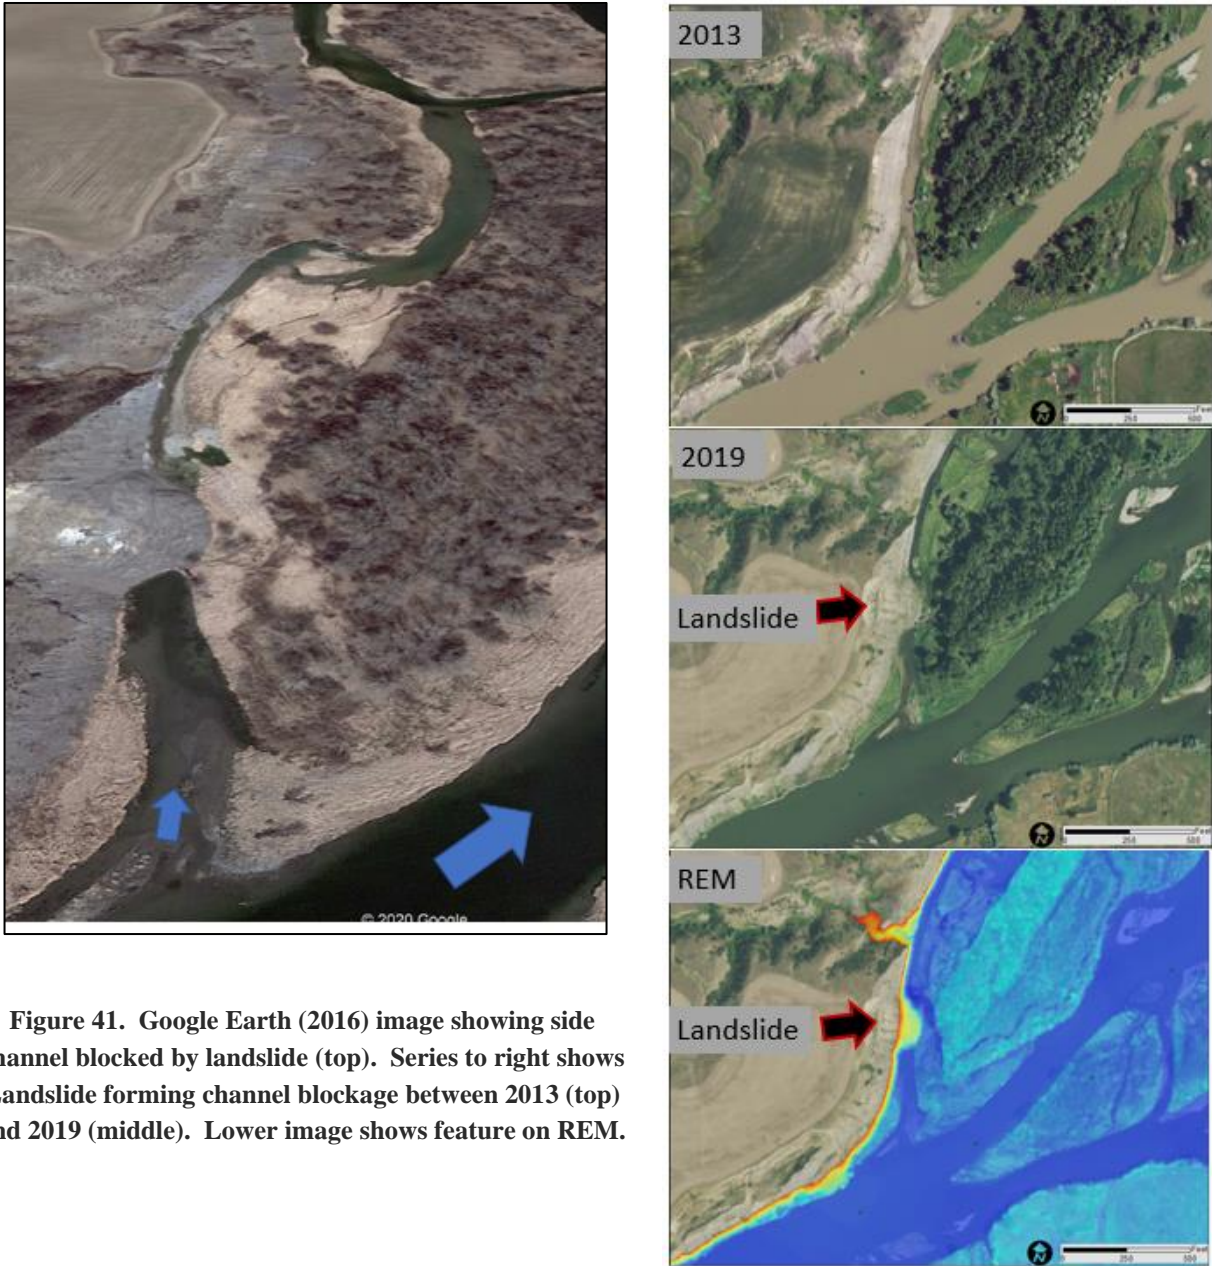
This site provides a really interesting opportunity for side channel reactivation. At this location a major side channel has been blocked by a landslide (Figure 41). The imagery suites indicate that the landslide happened sometime between 2013 and 2015. Figure 41 shows that by 2019, water may be flowing around the toe of the slide. A profile along the side channel shows the deposit to be about 10 feet thick along the side channel route. It would be appropriate to further explore this site to see if a channel is naturally forming around the slide, or if the blockage appears to be long-term without intervention. If that is the case, a pilot channel could be cut around the toe of the slide to greatly improve access into the 4,500 ft long side channel.

**Figure 41.** Google Earth (2016) image showing side channel blocked by landslide (top). Series to right shows Landslide forming channel blockage between 2013 (top) and 2019 (middle). Lower image shows feature on REM.

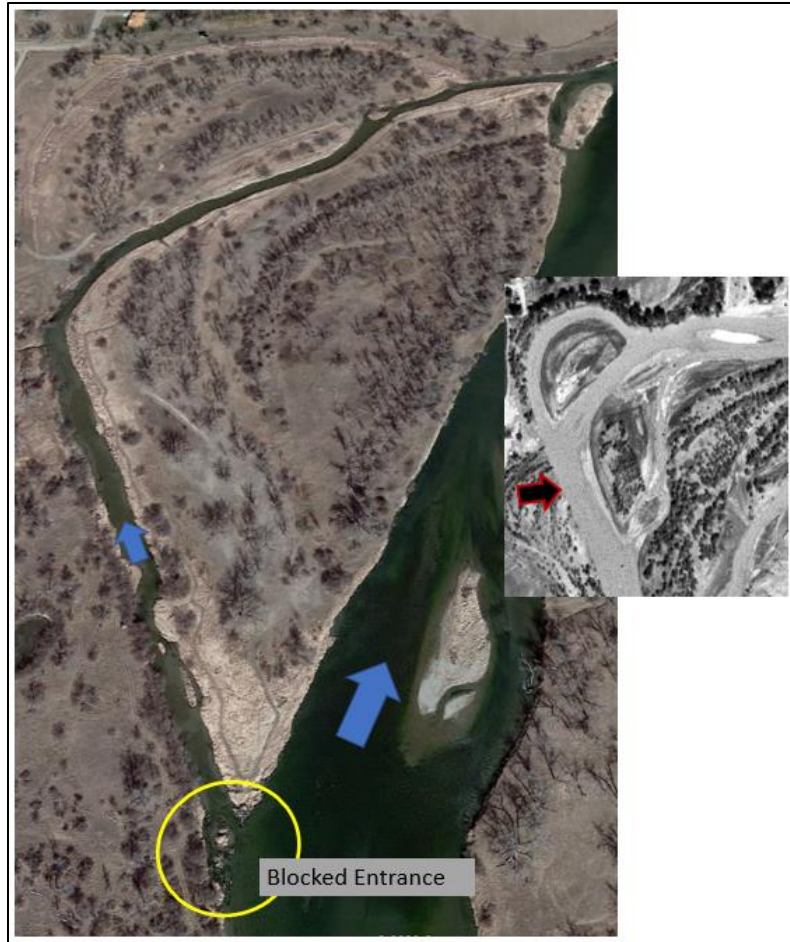
This channel is located about a half mile downstream from Grant Marsh Fishing Access Site. It is a large remnant channel that was the main thread of the river in the 1950s (Figure 43). The channel was flowing during the LiDAR flight so the blockage on the upstream end is not captured in the topography. Figure 44 shows the blockage; this photo was taken on January 23, 2020 when the river was flowing at about 3,500 cfs (courtesy of Dennis Fischer). Connectivity is generally well-established here, however fairly minor work at the head of the channel appears likely to increase flow volumes and frequencies, while intercepting the degradation trend. This channel has a well-developed morphology with strong banklines and some minor islands. The old channel shown in the upper left corner of the 1950s imagery (Figure 43) forms a high flow swale that could be potentially be integrated into a larger project although it is perched a few feet above the side channel, indicating substantial post-1950s deposition in the oxbow feature. Currently the swale supports wetland habitats (Figure 46); the most cost-effective means of reconnecting this feature is likely via excavation on its lower end, to create a connected backwater.

Figure 43. Google Earth Image (2016) showing partially disconnected side channel at RM 30.8; inset shows channel in 1954.

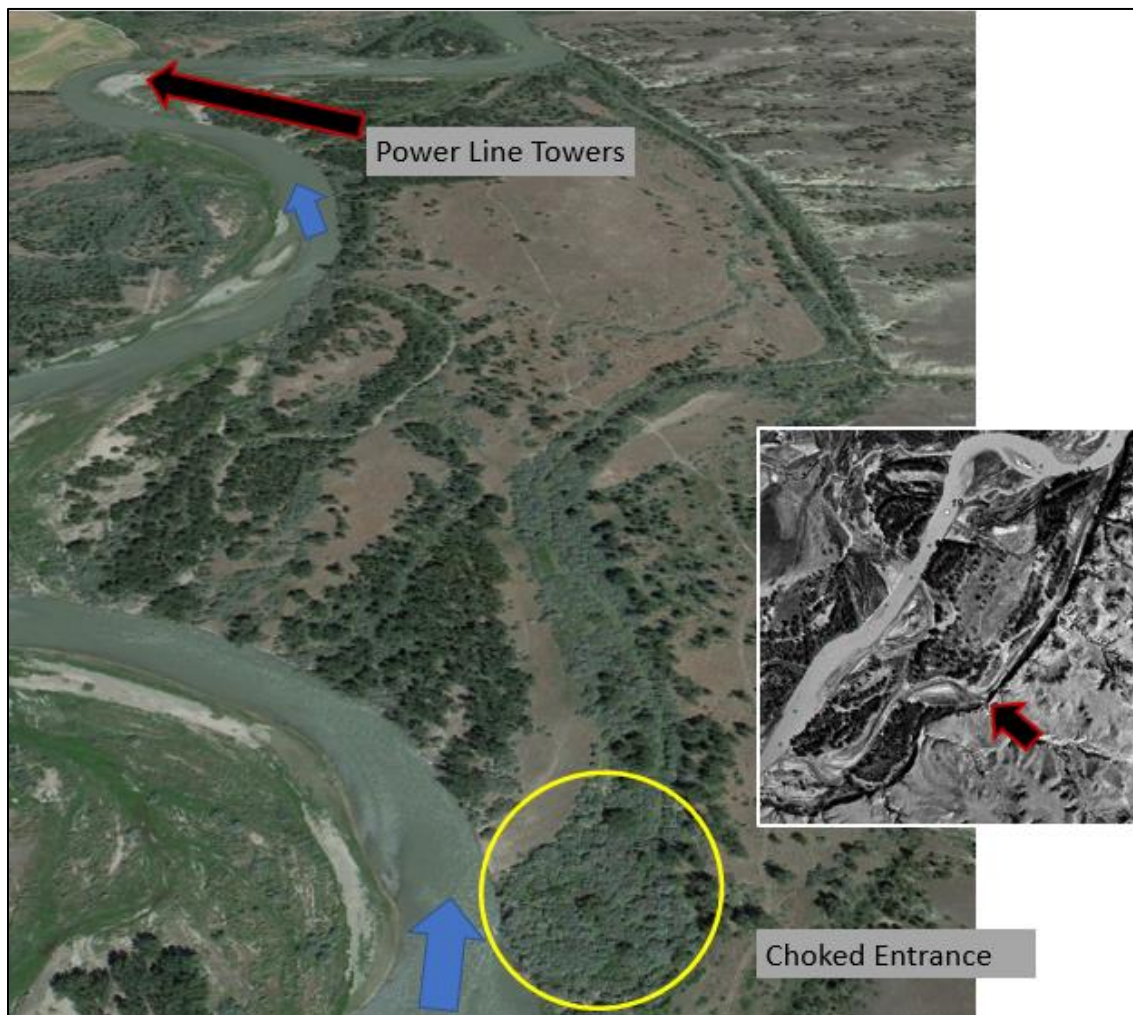
This side channel is over a mile long, and it was a prominent secondary channel in the 1950s (Figure 47). The LiDAR profile shown in Figure 48 suggests that dropping the elevation at the head of this channel to about one foot below the LiDAR river stage may be feasible. Currently the channel does not appear to activate at flows less than 10,000 cfs; excavation could potentially drop the activation discharge to below 5,000 cfs, which would equate to about two months a year of active flow, on average. Working on this channel would also require intensive Russian olive removal.

**Figure 47. Google Earth Image (2013) disconnected side channel at RM 19.9; inset shows channel in 1954.**

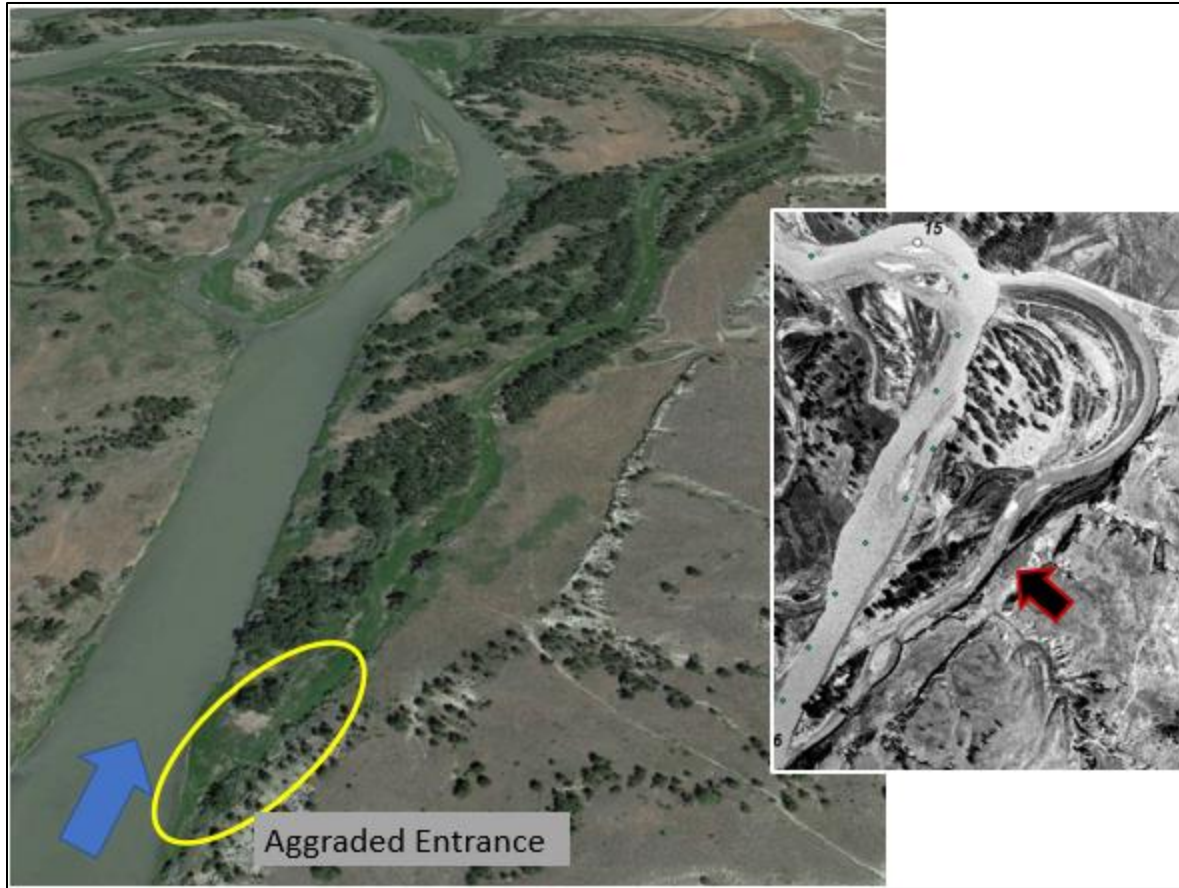
At RM 16, an old major side channel has become disconnected at its entrance due to deposition (Figure 49). A LiDAR profile shows substantial aggradation over the uppermost ~200 feet of the channel. Based on the LiDAR, excavation could increase the connectivity to about one foot below LiDAR stage, or about 5,000 cfs. On the lower river, this flow is equaled or exceeded about 17% of the time, or 62 days per year.

Figure 49. Google Earth Image (2013) disconnected side channel at RM 16.0; inset shows channel in 1954.

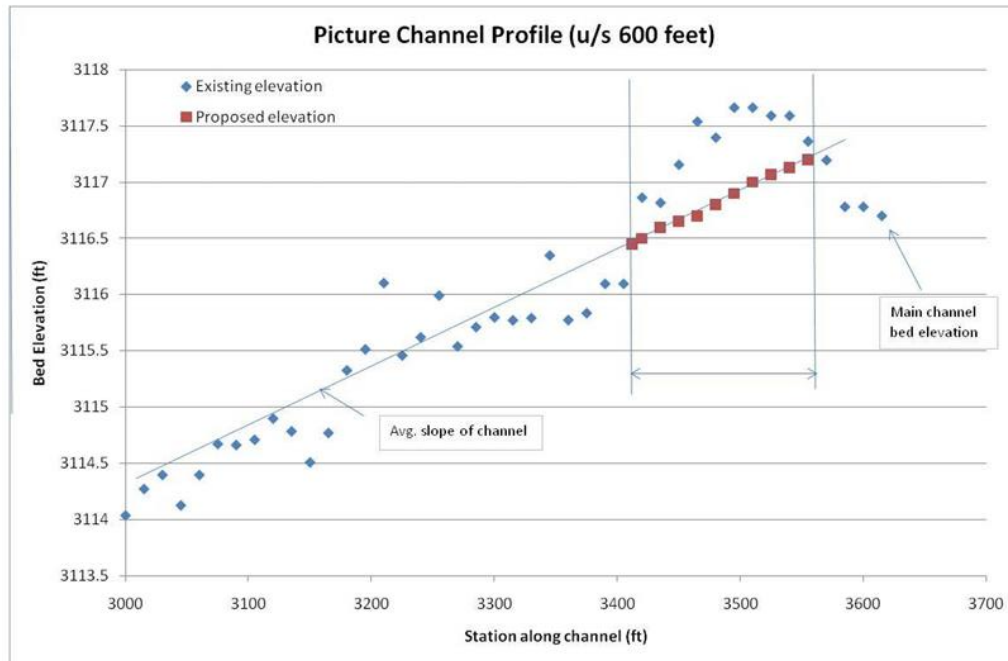
Figure 51. Picture channel profile showing proposed cut in red.

Figure 51 shows the proposed cut profile for Picture channel, to show that the approach is similar to the one taken with other side channels evaluated in this report (placing a design cut grade on the existing profile to determine the proposed entrance elevation). As for channel cross section, the proposed dimensions for the Cline's Channel and Picture Channel are listed in Table 10. Picture channel was unfortunately never excavated due to landowner issues, but Clines channel has remained open and functional. The 30-ft channel topwidth prescribed for both channels was increased from an original topwidth design of 15 feet. In this assessment, a topwidth of 20 feet has been used to reduce excavation volumes and cost.
