## BIGHORN RIVER SIDE CHANNEL RESTORATION POTENTIAL

THE RESEARCH INITIATIVE

**Karin Boyd**

February 2021

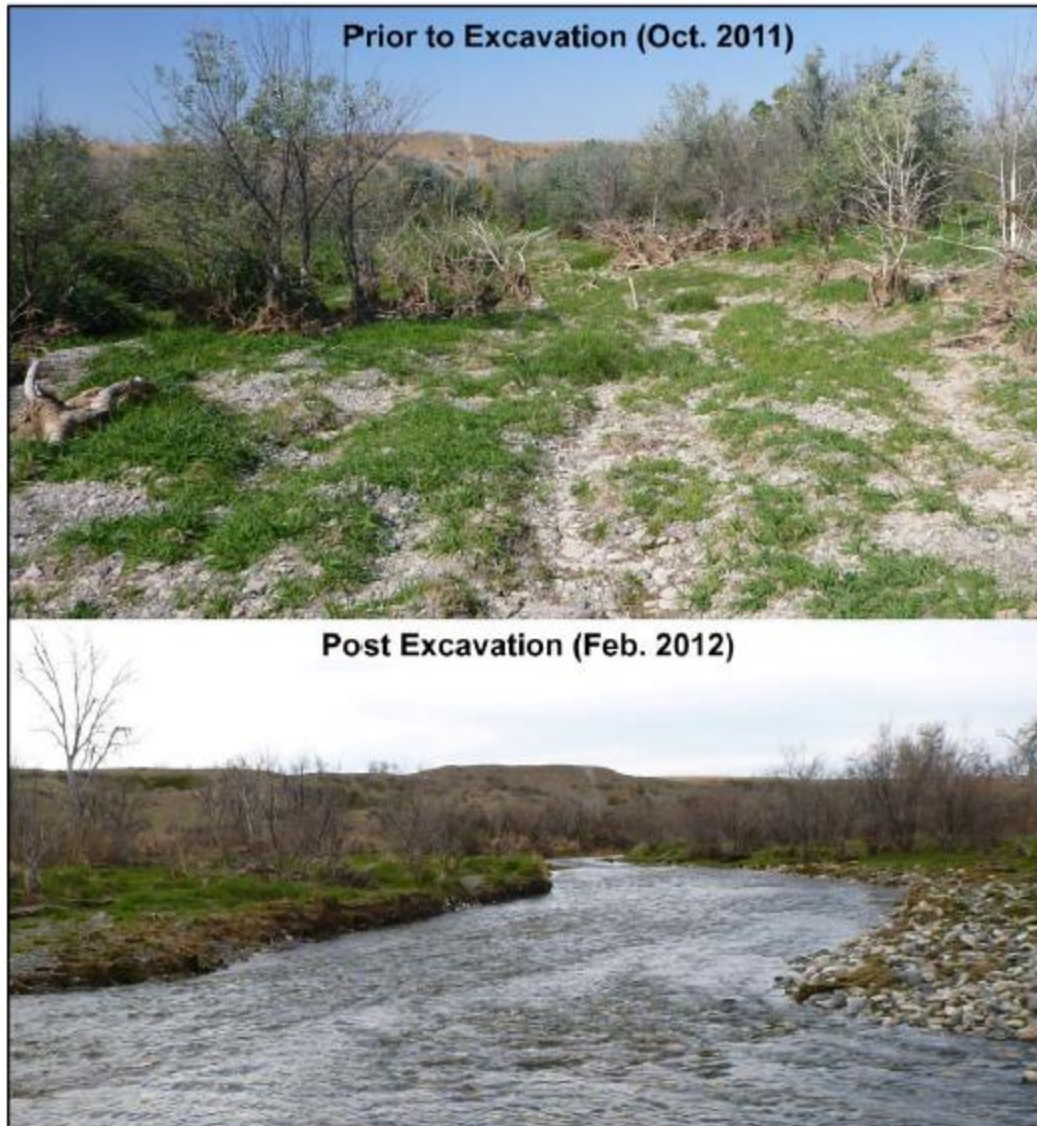
Clines channel was reactivated during between October 2011 and February 2012. Hilldale (2012) reported that Clines channel had become reconnected at about 2,000 cfs, as opposed to 5,500 cfs prior. Figure 2 shows the channel entrance pre- and post- restoration and Figure 3 and Figure 4 show that the connectivity has been maintained.

**Figure 2. Clines channel before (top) and after (bottom) excavation of the entrance at a Bighorn River discharge of ~3,100 cfs (Hilldale, 2012).**

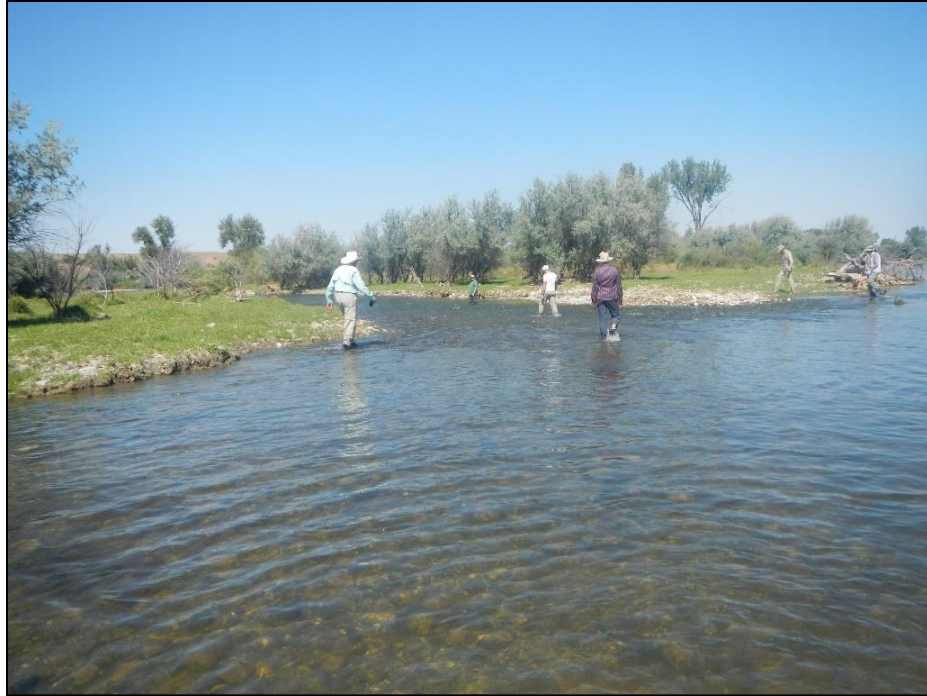
**Figure 3. Clines channel entrance at 3,200 cfs, September 5, 2019.**

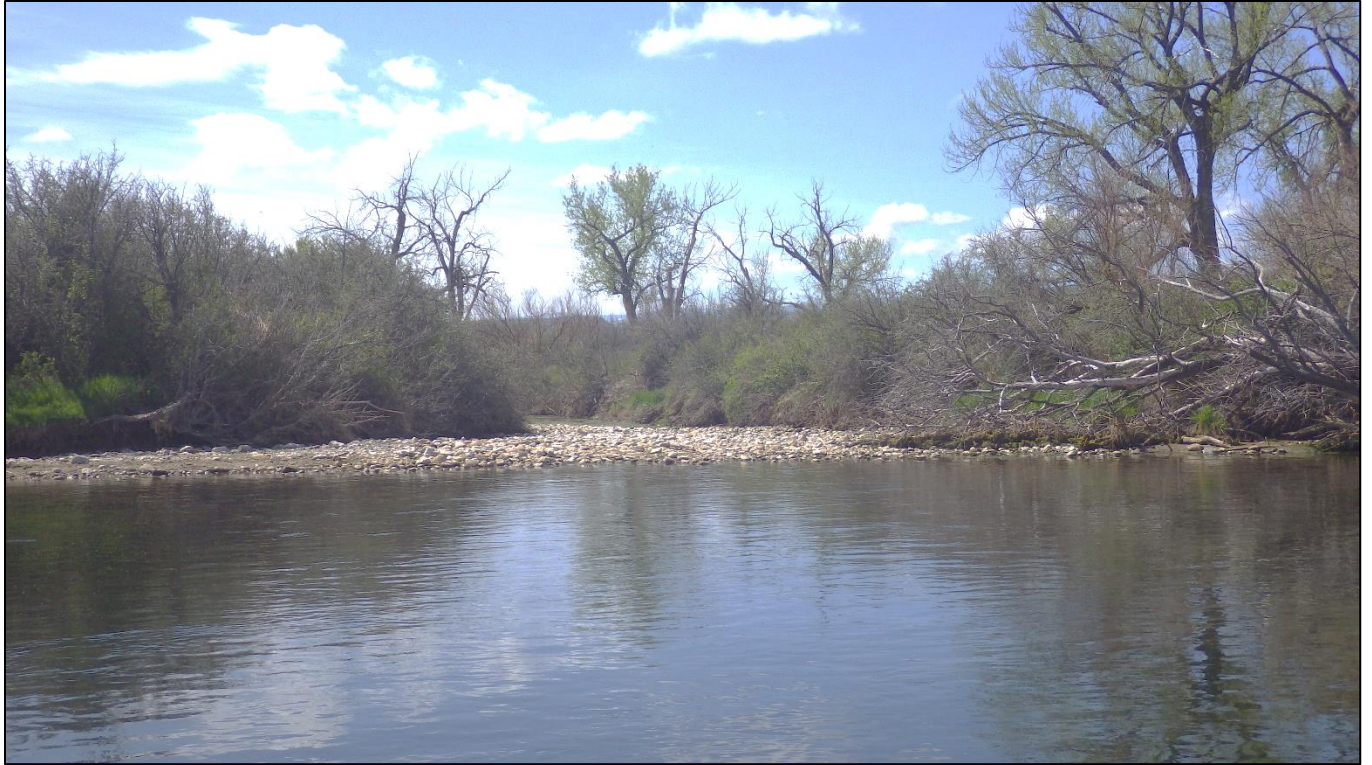
**Figure 14.** Entrance to Rattlesnake Island Channel at 2,500 cfs on May 18, 2020 (Steve Hilbers photo).

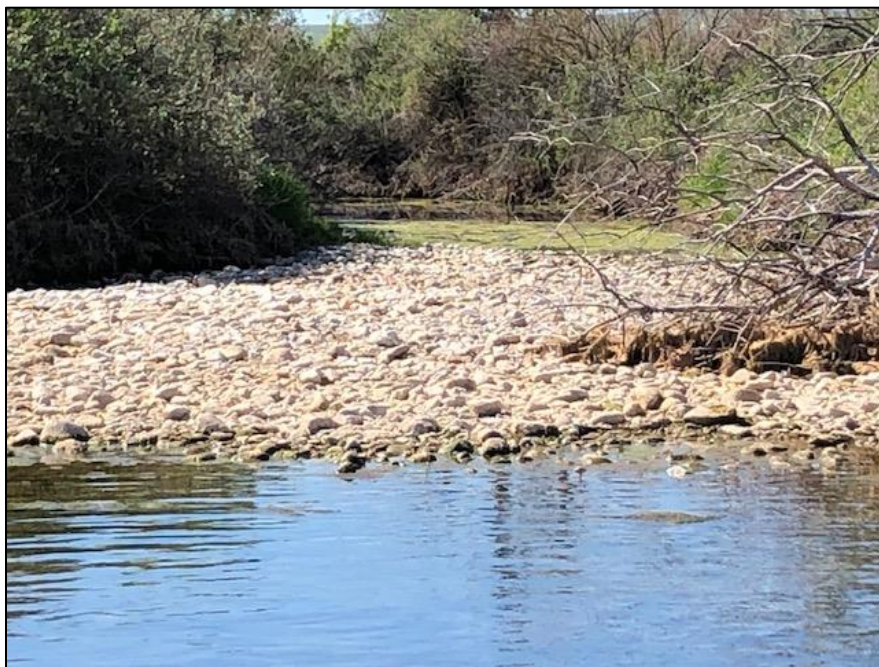
**Figure 15.** Entrance to Rattlesnake Island Channel at 2,000 cfs on May 29, 2020 (Jim Chalmers photo).

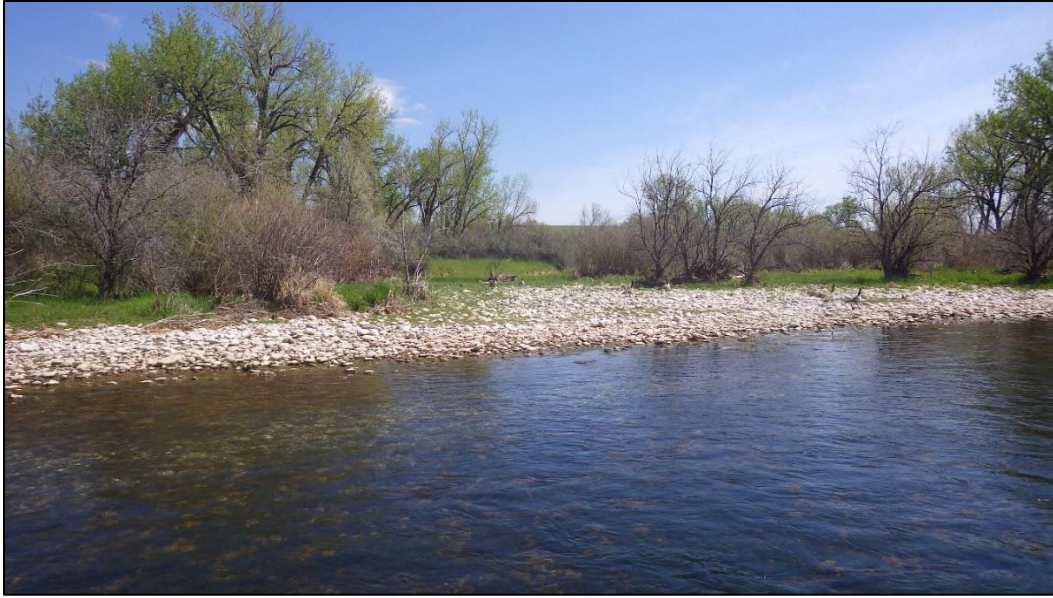
This channel flows through an island across from the car body riprap known as “Drive In” (Figure 16). The USGS estimated this channel to activate at 3,475 cfs (Table 1). During our field investigation in September, it was dry by about 0.3 feet, when flows were at 3,200 cfs. It was also dry in May 2020 at 2,500 cfs (Figure 17). If the entrance were lowered by 0.4 feet, the activation of this channel should occur at about 2,000 cfs. This channel has a robust willowed bankline, an emergent wetland on its lower end, and gravelly substrate in its bed (Figure 18 and Figure 19). This would increase that average duration of flows to this ~1,500 ft long channel from approximately 117 days per year to 250 days per year. As the channel is on an island, access may be a challenge; potential approaches to work from the river are described in Chapter 5.

**Figure 17. View into RM 78.8 side channel at 2,500 cfs on May 19, 2020 (Steve Hilbers photo).**

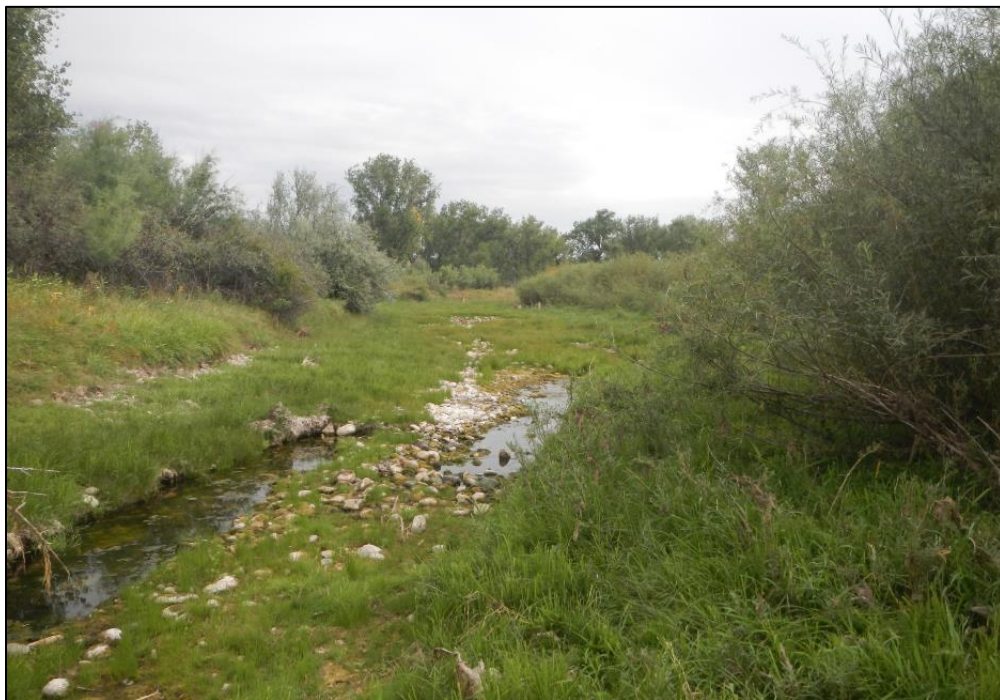
**Figure 18. View downstream of side channel at RM 78.8 showing robust bankline vegetation and coarse substrate.**

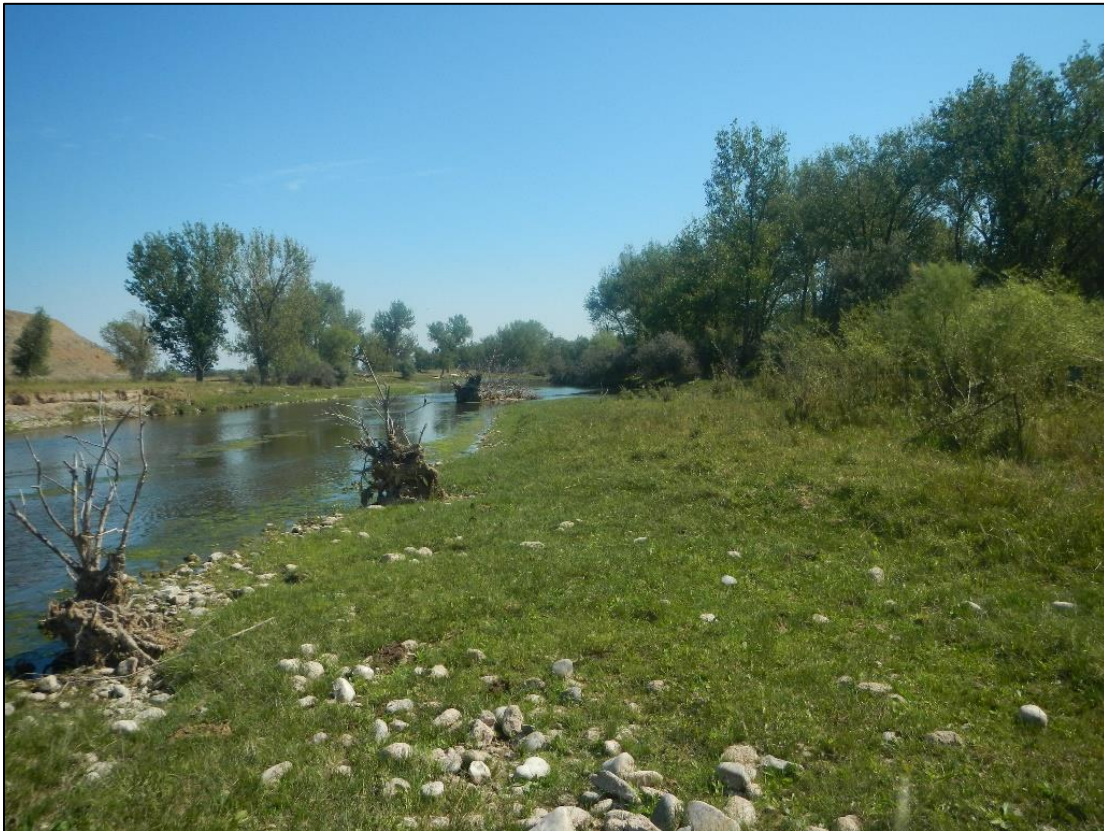
This is a top-tier channel that has already been designed for 0.5 feet of excavation and 80 cubic yards of removal. The channel was flowing during the field work at 3,200 cfs (Figure 23) but was almost dry at 2,500 cfs in May of 2020 (Figure 22) and completely dry at 2,000 cfs ten days later (Figure 25). Although the channel seasonally dries, the 2006 imagery which shot when flows were about 1,500 cfs, shows that the channel has not decayed but continues to support open gravels along its length (Figure 26). This is a top-tier channel that will hopefully be able to get done in coming years as it provides excellent habitat area in return for minor excavation. According to available files, the proposed design is to drop the entrance elevation by about 0.5 ft. This should reduce the flows required to wet the channel from about 3,000 cfs currently to approximately 2,200 cfs. Currently, Picture Channel has a debris jam formed at the flow split- these features, which are commonly called “apex jams” or “bifurcation jams”, can be used in project designs to promote stable flow splits (Figure 27 and Figure 28).

**Figure 23. View downstream of Picture Channel at Bighorn River flow of 3,200 cfs (Sept 2019); note high water marks on bankline vegetation.**

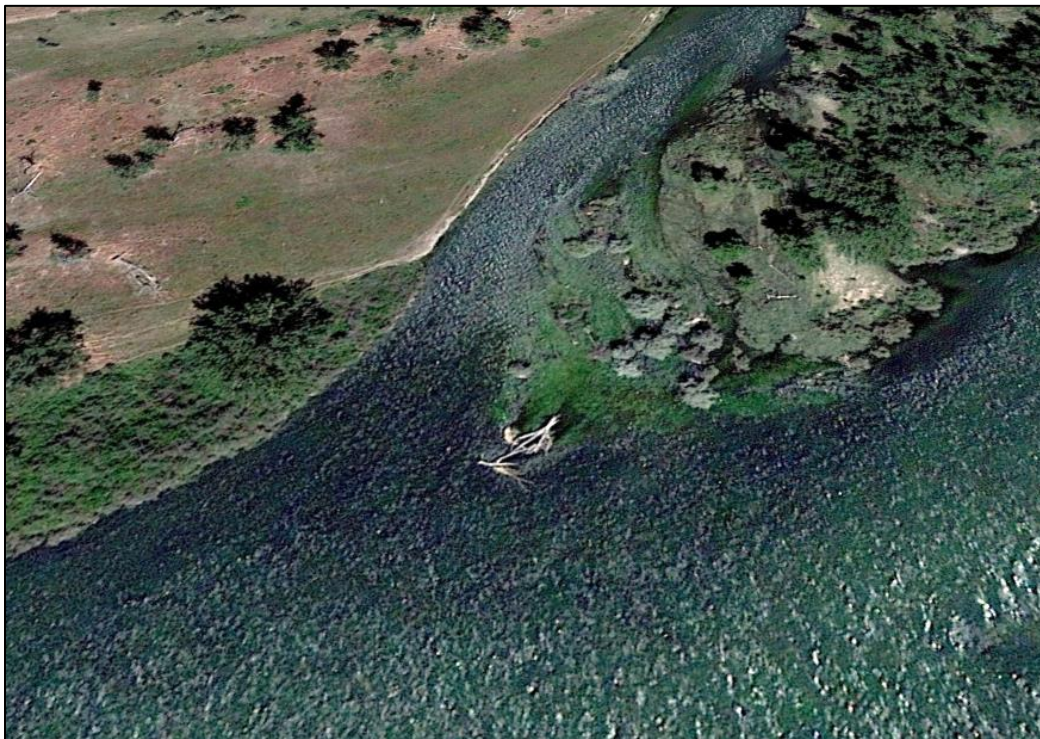
Figure 27. Debris jam at Picture Channel flow split showing how feature facilitates side channel flow.

Picture Channel work has been designed by the Bureau of Reclamation, and more recent survey data should be sufficient to revise that design as necessary. There currently a large woody debris jam at the head of the flow split, these features are effective at diverting flow into side channels hence I would recommend that it remain in place. If an agreement can be made with the landowner, this would be an appropriate channel to approach by removing the material at the head of the channel and relocating it to upland areas to the north. This may preclude the need for a 404 permit from the Corps of Engineers, but they should be contacted to make sure that is correct.

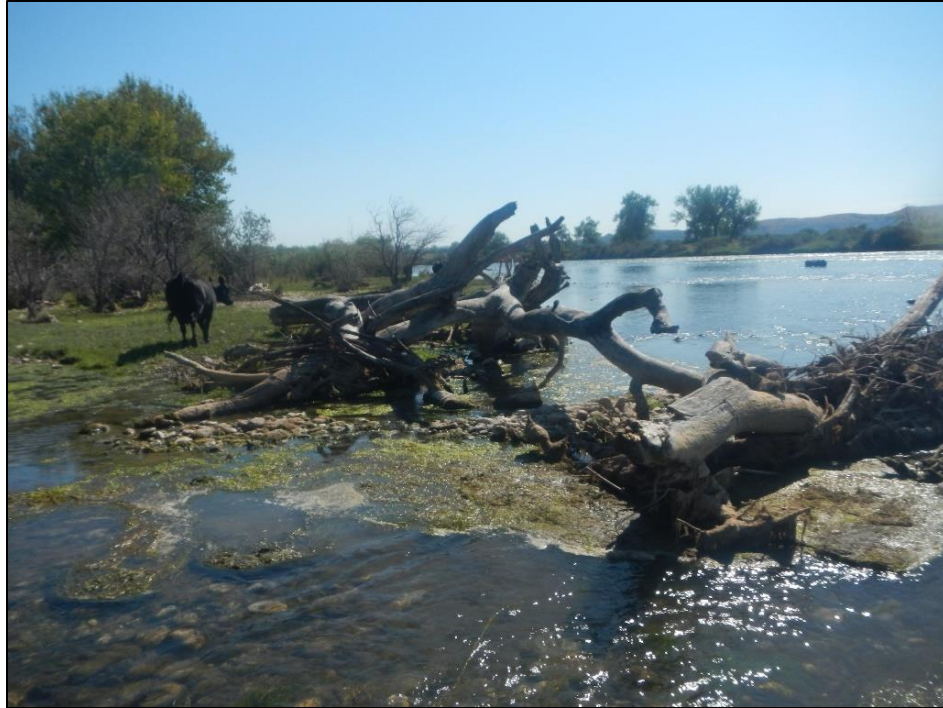
Figure 28. View downstream of log jam at head of Picture Channel; main Bighorn River channel is to right (~3,200 cfs).

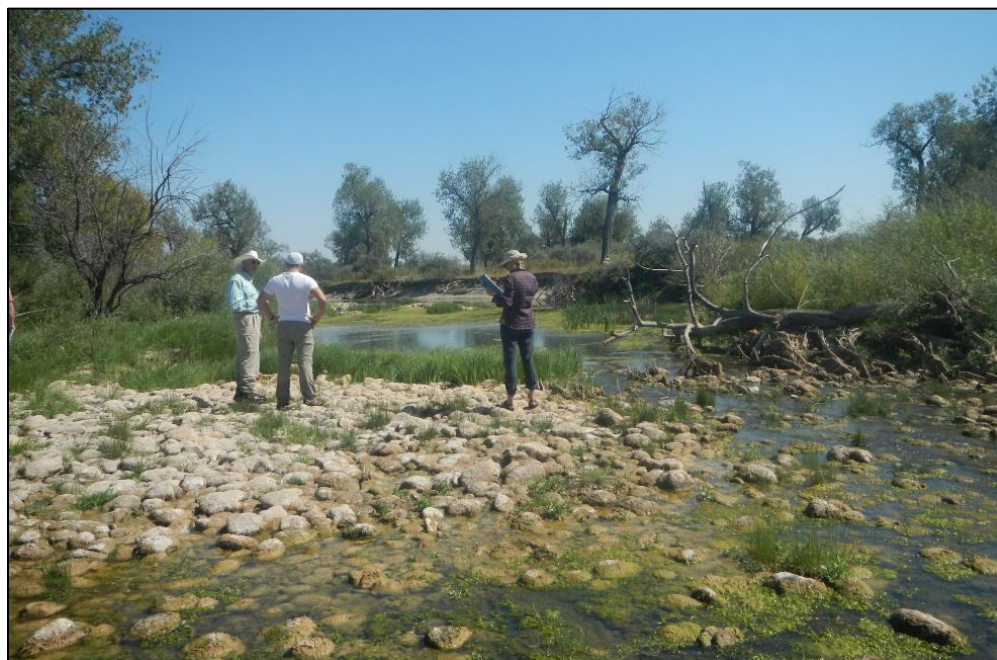
Figure 30. View downstream into Juniper Channel (3,200 cfs).

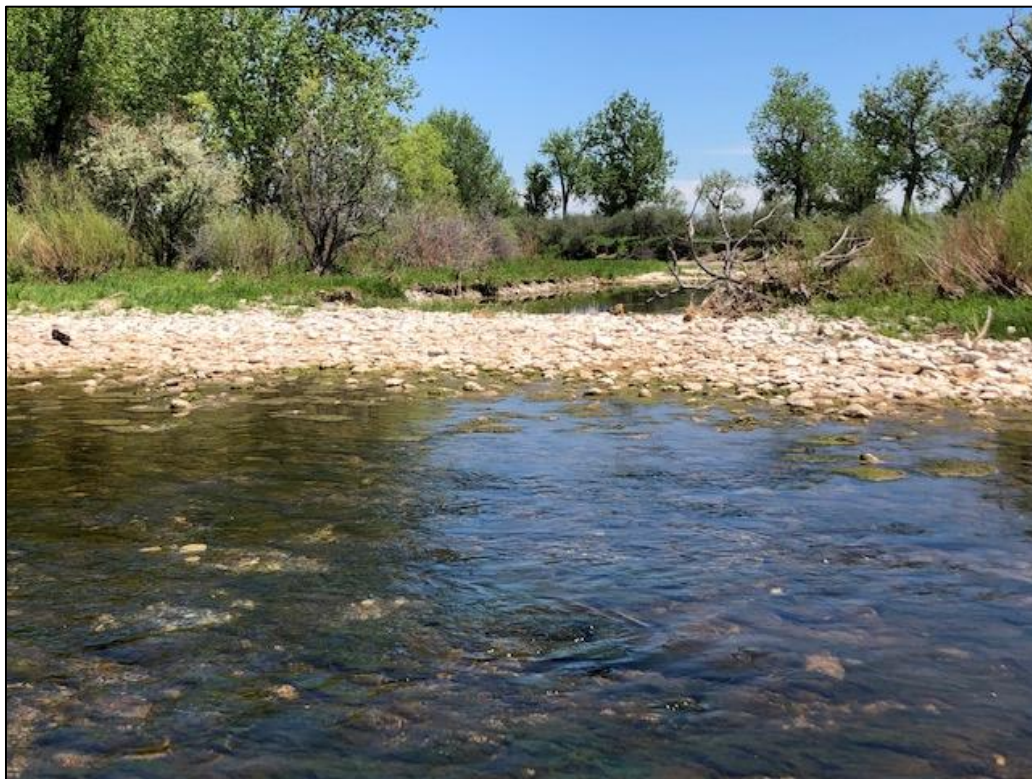
At RM 76.4, the Juniper Channel existed in the 1950s as a secondary channel behind a mid-channel bar. This bar has progressively established as a vegetated island, but the secondary channel has persisted since the dam was built. (Figure 29). The channel was flowing during our field work, when the river discharge was about 3,200 cfs (Figure 30), and in May of 2020 it was dry at 2,500 cfs (Figure 31). Figure 32 shows the entrance at 2,000 cfs. Based on stage comparisons, the estimated activation flow is about 2,900 cfs. If the entrance were dropped about 0.4 feet, the estimated activation could be dropped to about 2,300 cfs, which would wet the channel an additional 50 days per year. The material at the head of the channel is quite coarse, and it appears unlikely that it will naturally scour at high water, so mechanical excavation is likely necessary to maintain connectivity and prevent additional decay through vegetation encroachment onto the cobbles. The shallow water in the foreground of Figure 32 suggests that deep excavation through the head of Juniper Channel may be difficult.

**Figure 32. Entrance to Juniper Channel at 2,000 cfs on May 29, 2020; note shallow water in foreground (Jim Chalmers photo).**

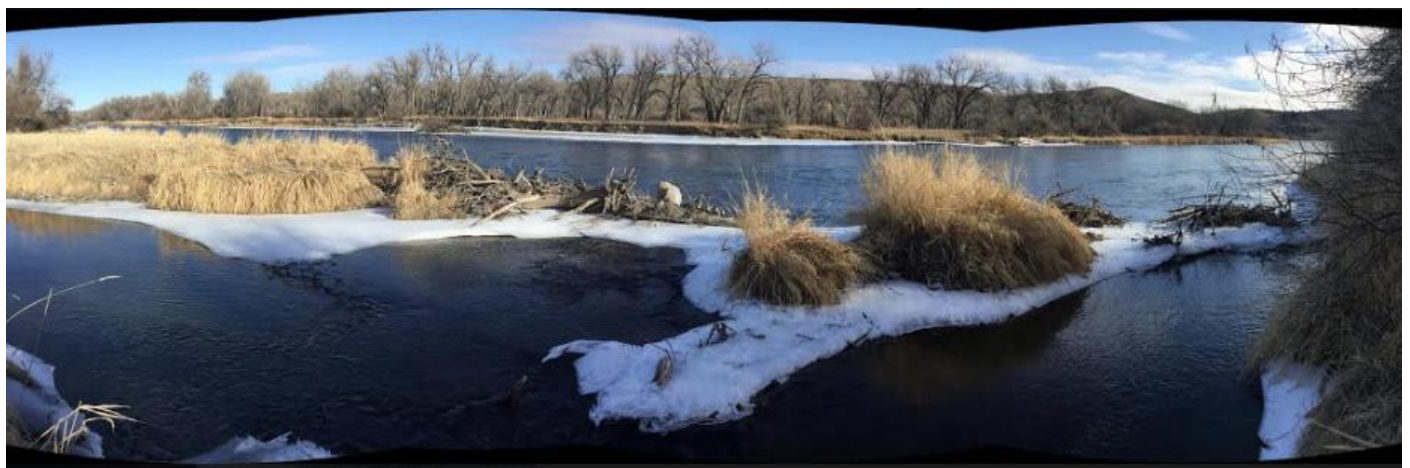
This channel is located about a half mile downstream from Grant Marsh Fishing Access Site. It is a large remnant channel that was the main thread of the river in the 1950s (Figure 43). The channel was flowing during the LiDAR flight so the blockage on the upstream end is not captured in the topography. Figure 44 shows the blockage; this photo was taken on January 23, 2020 when the river was flowing at about 3,500 cfs (courtesy of Dennis Fischer). Connectivity is generally well-established here, however fairly minor work at the head of the channel appears likely to increase flow volumes and frequencies, while intercepting the degradation trend. This channel has a well-developed morphology with strong banklines and some minor islands. The old channel shown in the upper left corner of the 1950s imagery (Figure 43) forms a high flow swale that could be potentially be integrated into a larger project although it is perched a few feet above the side channel, indicating substantial post-1950s deposition in the oxbow feature. Currently the swale supports wetland habitats (Figure 46); the most cost-effective means of reconnecting this feature is likely via excavation on its lower end, to create a connected backwater.

Figure 44. View upstream of channel entrance at RM 30.8 (Dennis Fischer photo).

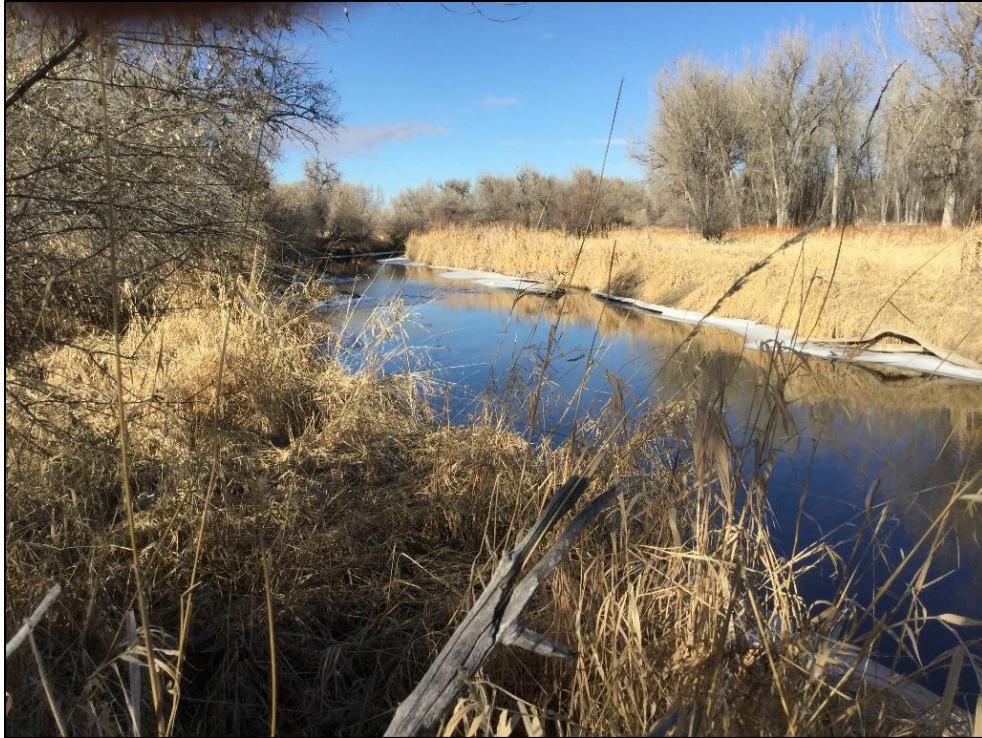
**Figure 45. View downstream of side channel at RM 30.3 (Dennis Fischer photo).**

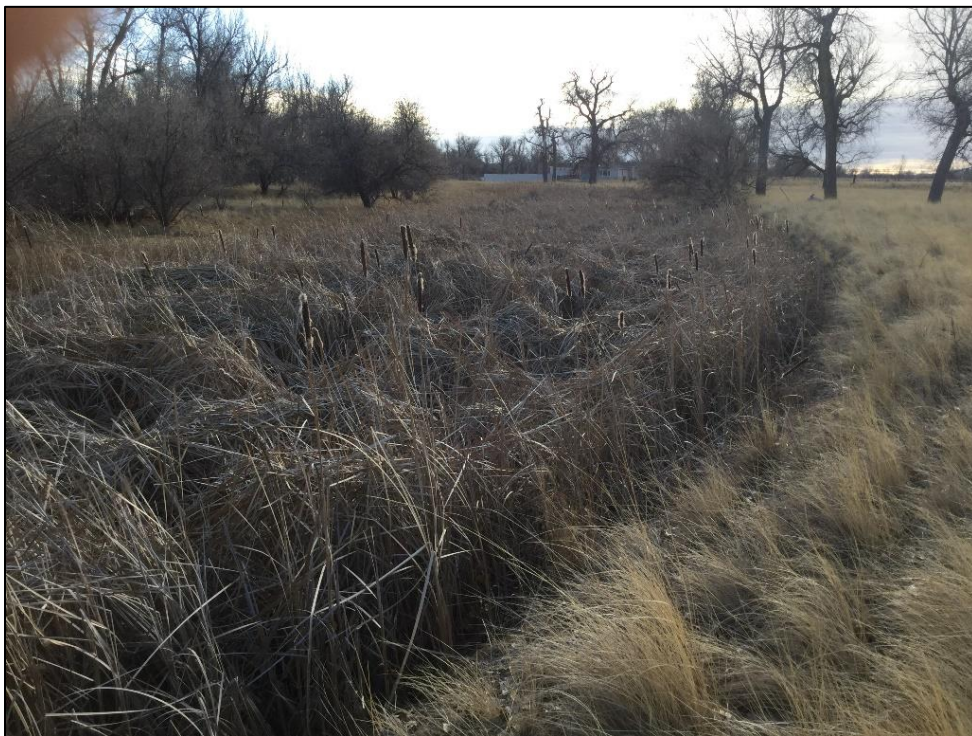
**Figure 46. Overflow swale that connects to side channel at RM 30.3 (Dennis Fischer photo).**

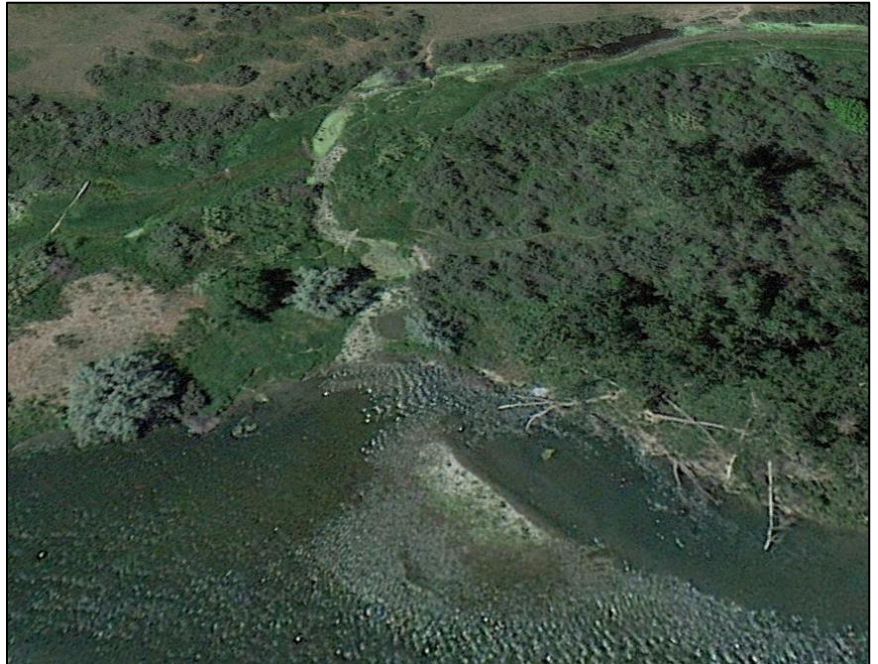
This channel appears to be activated sometime between about 2,200 and 3,000 cfs. A depositional bar has developed at the mouth of the channel, which has created a small channel along the bank that is about 50 feet wide. This site could be evaluated to see if reshaping that bar and the channel entrance could effectively route water into the channel under most flows (Figure 54). This channel also provides an excellent opportunity for habitat restoration along its course, including riparian restoration and instream morphologic enhancement of habitat elements (pools/riffles/large wood).

**Figure 54.** View downs side channel at RM 63.3 showing potential to route additional flows with excavation and/or bar reshaping.
