## BIGHORN RIVER SIDE CHANNEL RESTORATION POTENTIAL

THE RESEARCH INITIATIVE

**Karin Boyd**

February 2021

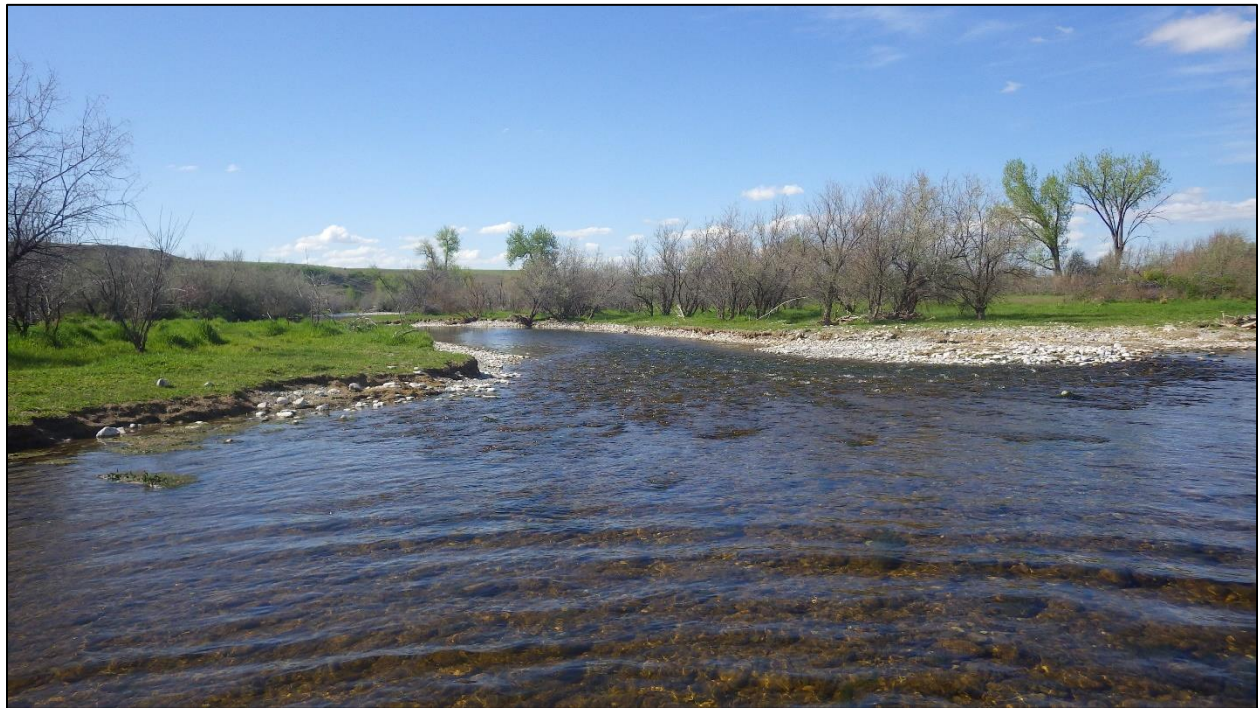
**Figure 4. Clines channel entrance at 2,500 cfs, May 19, 2020 (Steve Hilbers photo).**

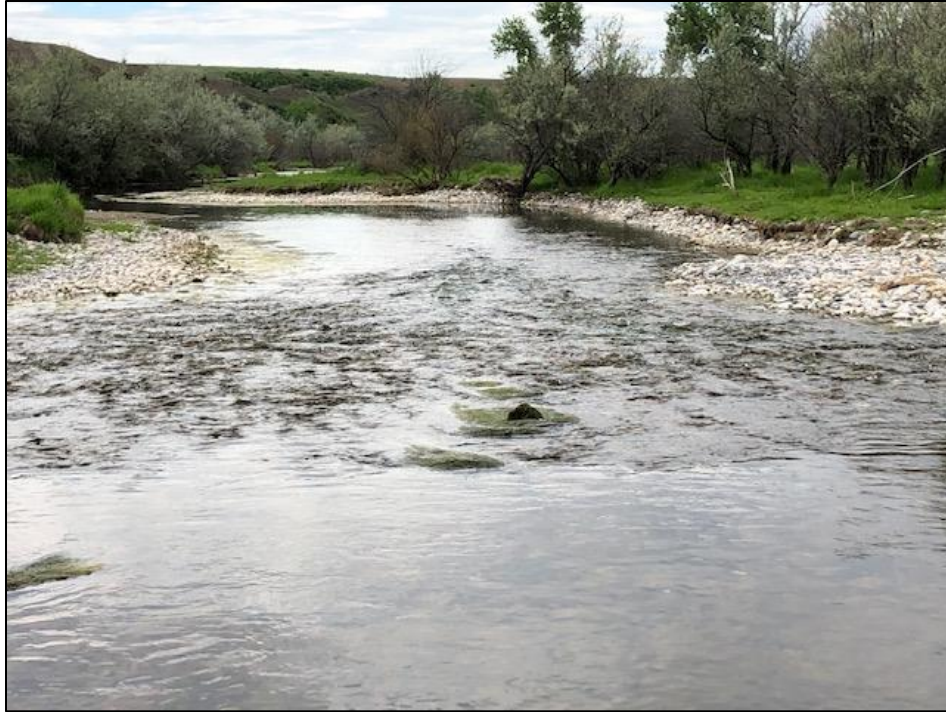
**Figure 5. Clines channel entrance at 2,000 cfs, May 29, 2020 (Jim Chalmers photo).**

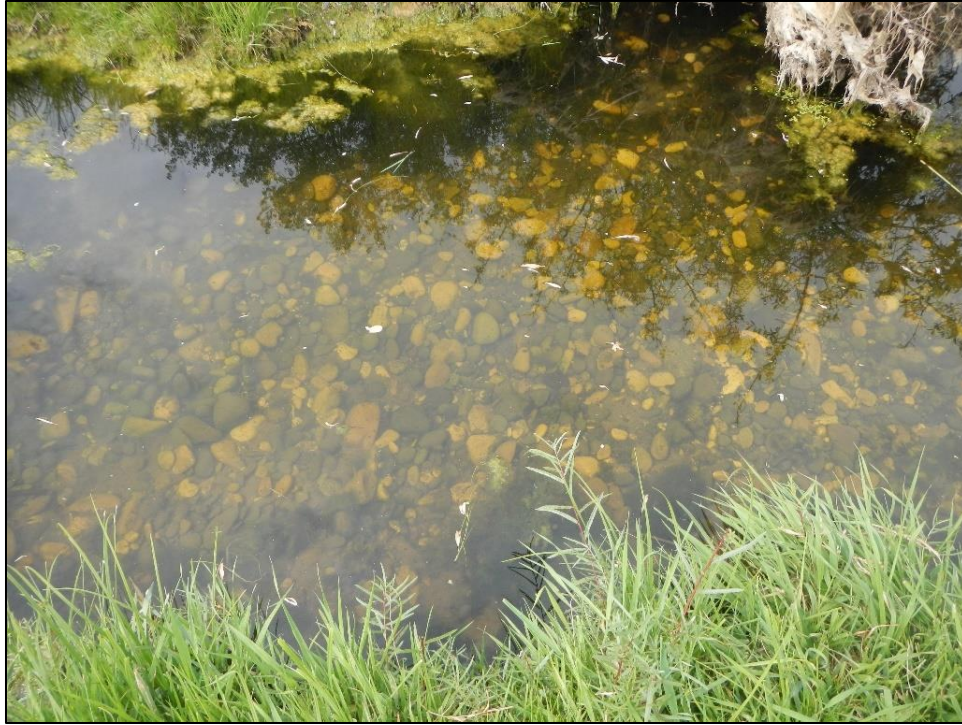
**Figure 19. Gravel substrate in lower end of disconnected channel at RM 78.8.**

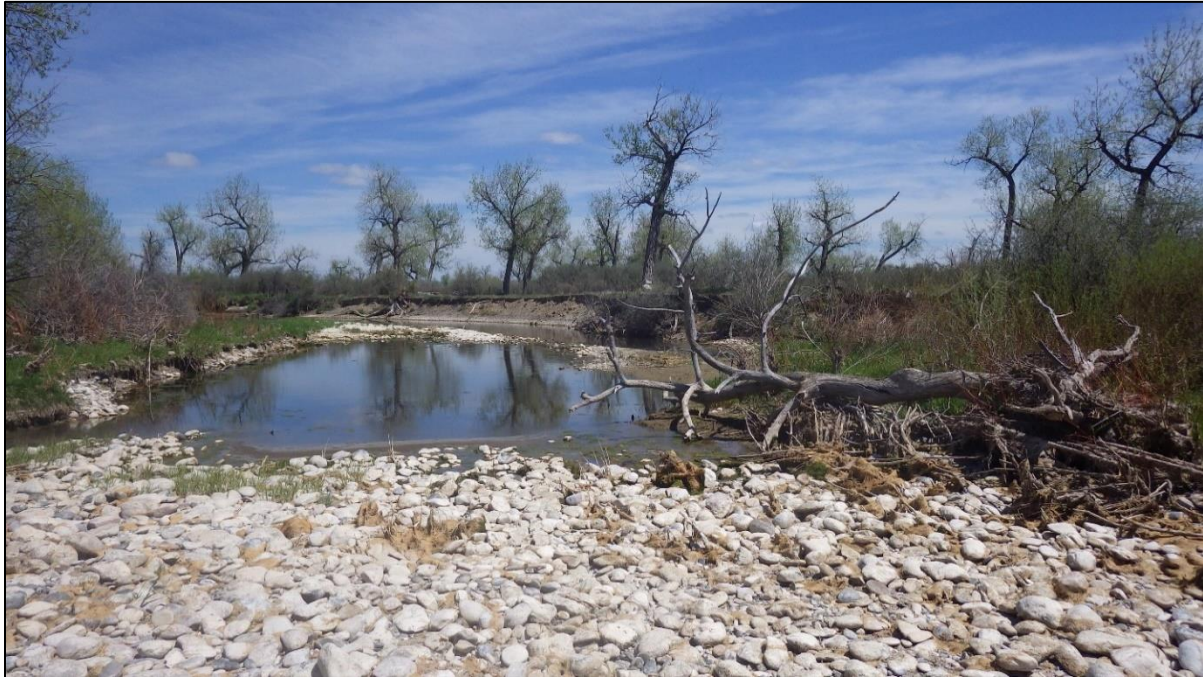
**Figure 31. Entrance to Juniper Channel at 2,500 cfs on May 19, 2020 (Steve Hilbers photo).**
